Field research on burrows and discontinuities in embankments

Fact Finding field research in the Hedwige-Prosperpolder

STOWA Report no:

2021-52

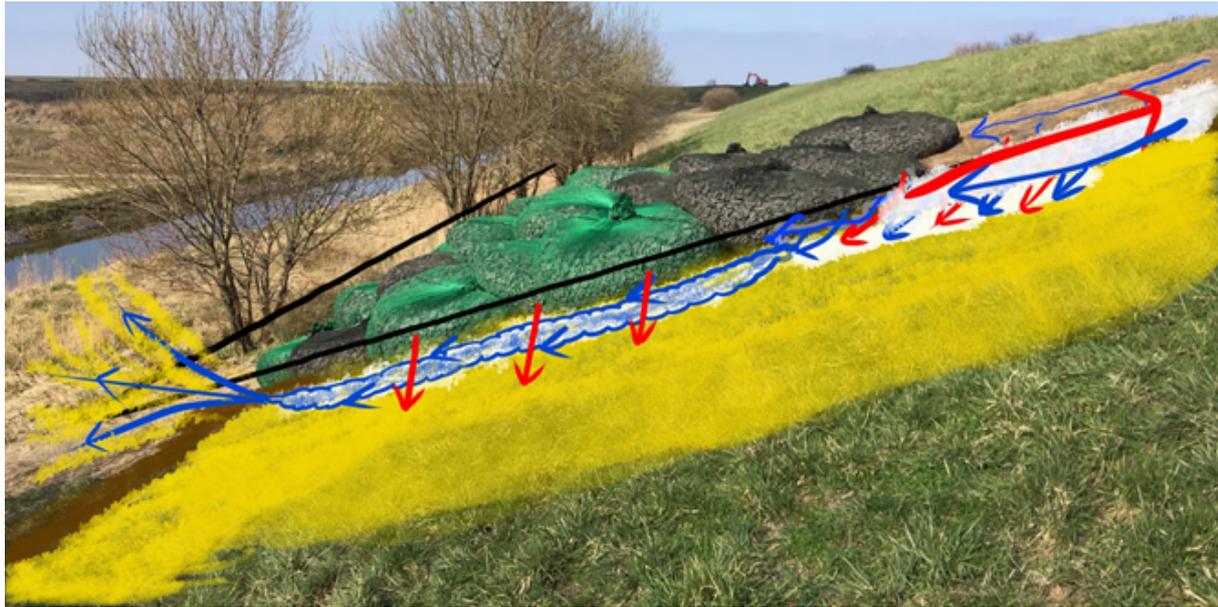
Figure 1 Sketch of assumed mechanism. Blue arrows symbolise the water flowing from the top of the levee through preferential flow paths, underneath the rock bags where sand is picked up. The red arrows indicate what happens: subsidence of the rock bags and erosion of the sand core and damage of the clay cover above the rock bags.

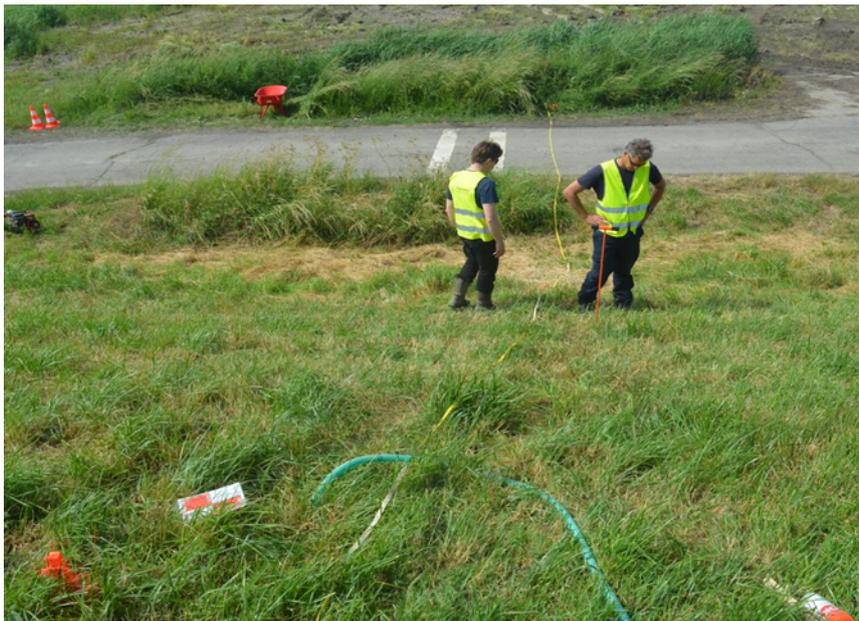
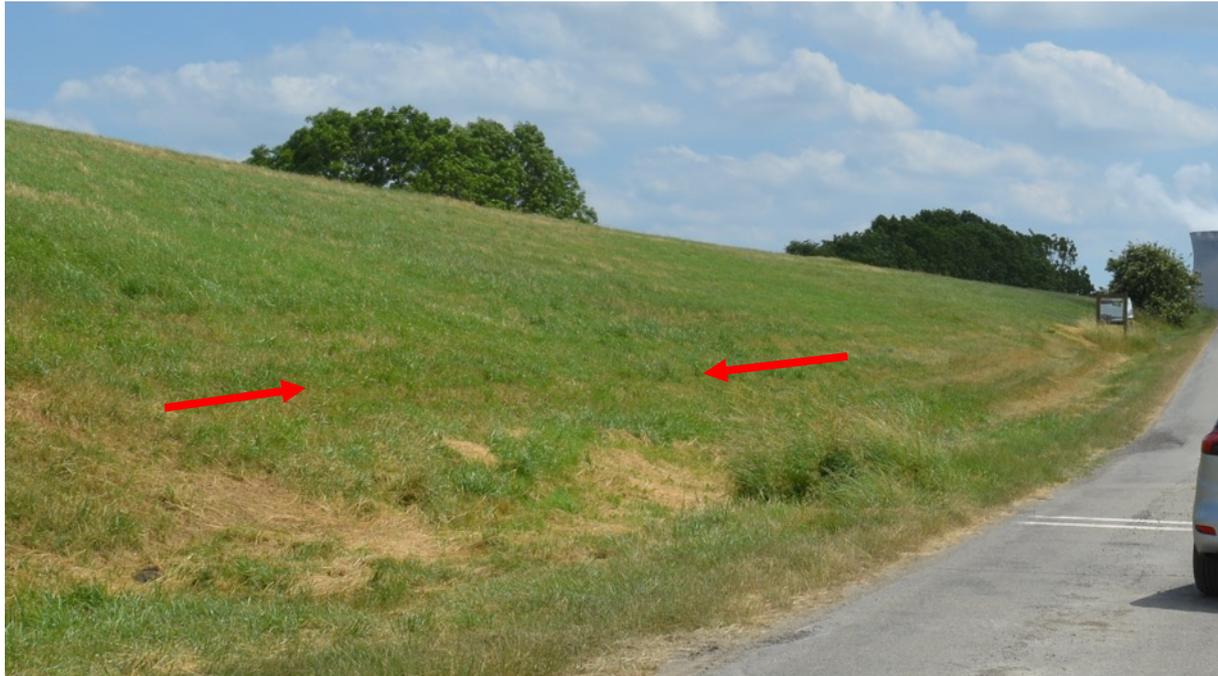
At the Dutch site presumed animal burrows and other discontinuities were observed. A large rip with a length of 25 to 30 metres with a depth of at least one metre (a 1 metre probe could effortlessly be entered over its full height at various locations along the rip), possibly caused by a locally slid clay cover, was observed. The observed local sliding of the clay cover resulted in rip in the clay cover. At the toe of the levee near the rip moist-loving vegetation (reed) grew (see Figure 4). The rip could, as was presumed, have made a connection with the underlying sand core (not touched with the aforementioned probe).

Figure 4 Rip observed at Dutch location 2 meters above a small reed vegetation, shown in both pictures.

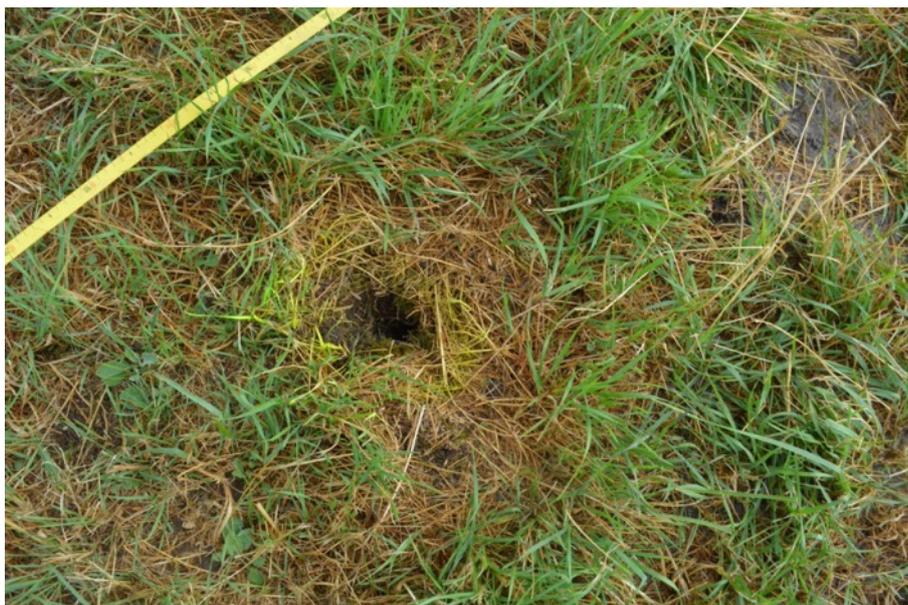
Figure 5 Holes of animal origin or cracks are marked yellow

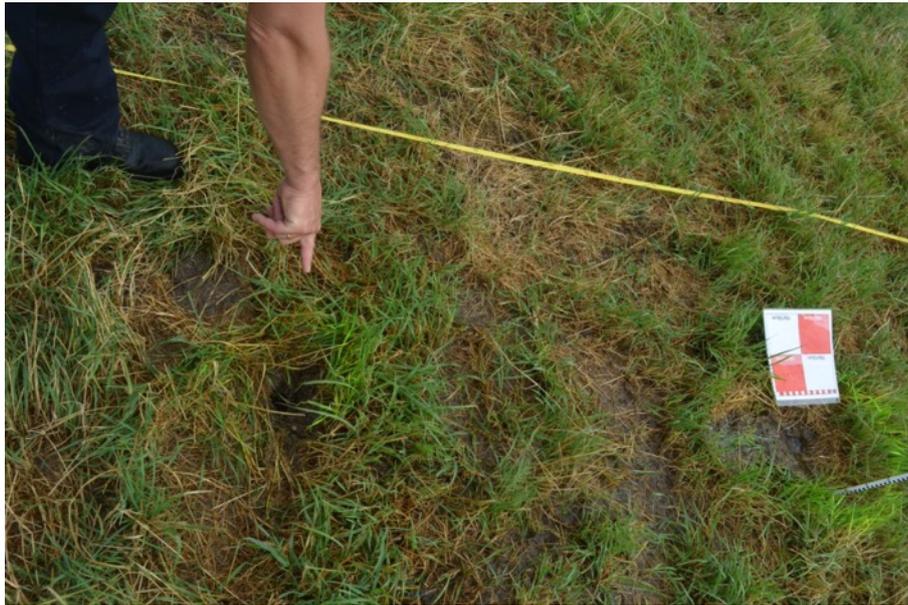
For site location 2 in The Netherlands, several exit points were clearly observed (Figure 6).

Figure 6 Identification of exit point

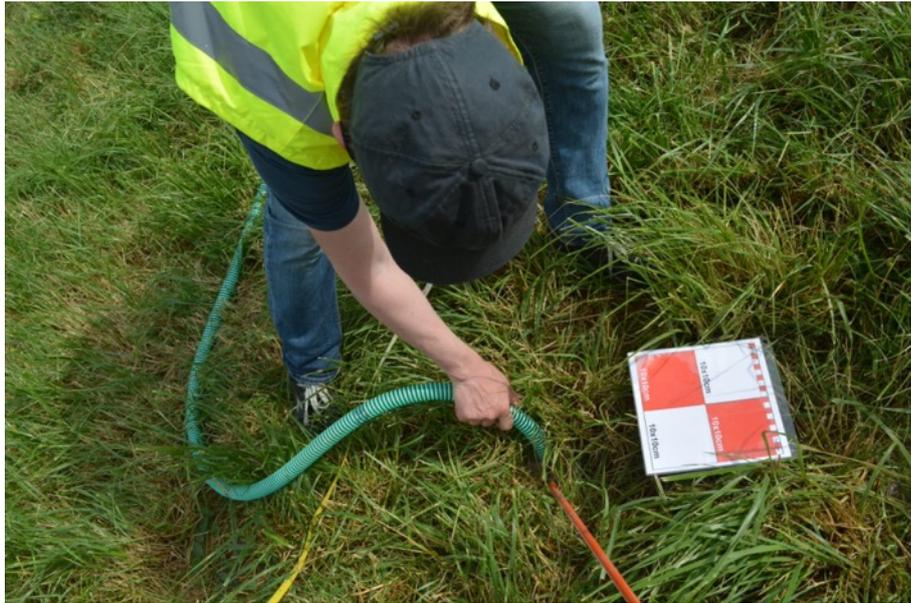
Based on visual observations, location of entry points were subjected to flow rates of ca. 1 l/s (see Figure 7). These flow rates made it possible to observe preferential flow paths, because of the visible water flows at the exit points. Above the reed zone at the toe of the levee, the water did not appear at the surface but seemed to disappear in the core of the levee. With use of a hand-held-inspection-probe (Dutch: *prikstok*, e.g. visible in the upper picture in Figure 4) the observed rip which may have caused the water to flow internally away was inspected.

Figure 7 Identification of preferential flow paths due to water infiltration

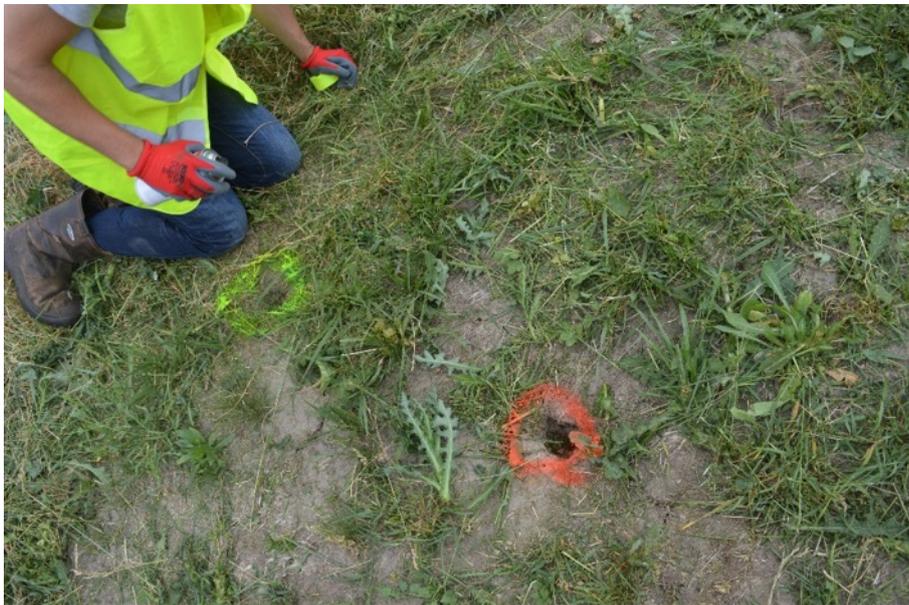
Figure 9 Marking burrows and discontinuities that are suspected from human interventions (Yellow) or from animal activities (Orange)

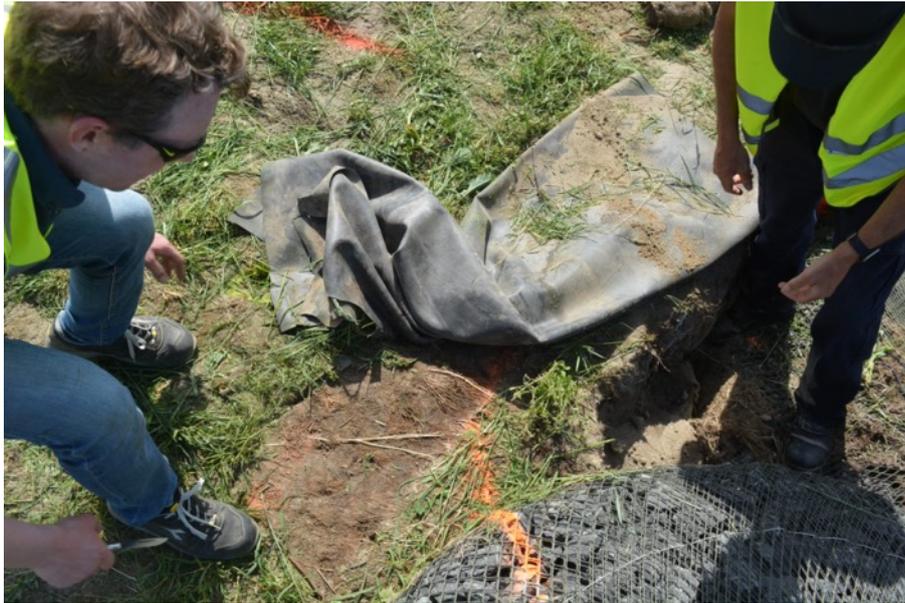
The presence of the Rock Bags on the Belgian site (Patrik's cliff) prohibited the determination of the exact location of the exit points (Figure 10).

Figure 10 Untraceable exit points nearby the rock bags

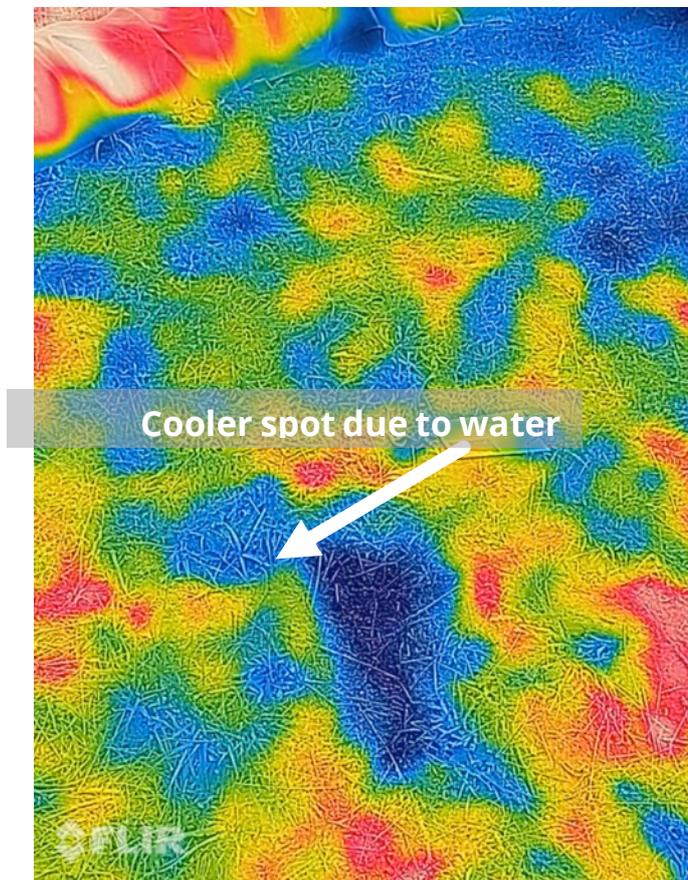
As test infrared measurements were carried out during the test to identify the exit points of the water flows (Figure 11). Although these infrared measurements detected a difference in temperature on the locations where water flowed out of the exit points, the infrared measurements were of no added value during the field test because the exit points were clearly visible.

Figure 11 infrared measurements

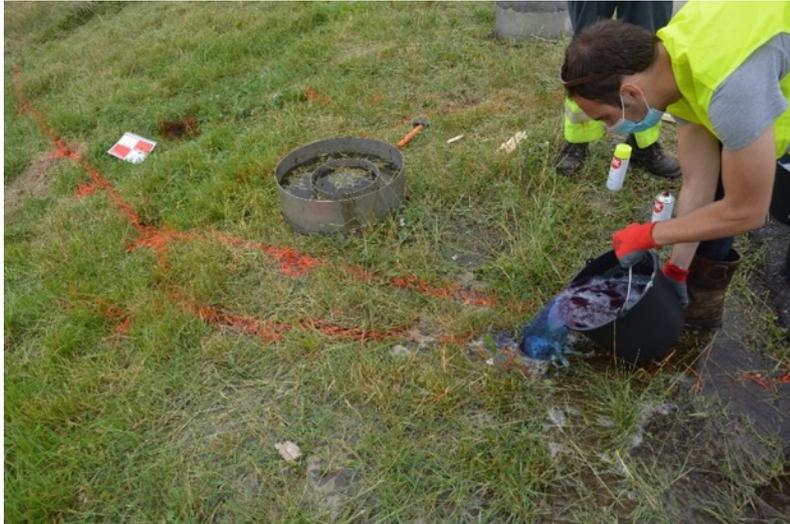
Figure 12 Application of colourant to find preferential flow paths

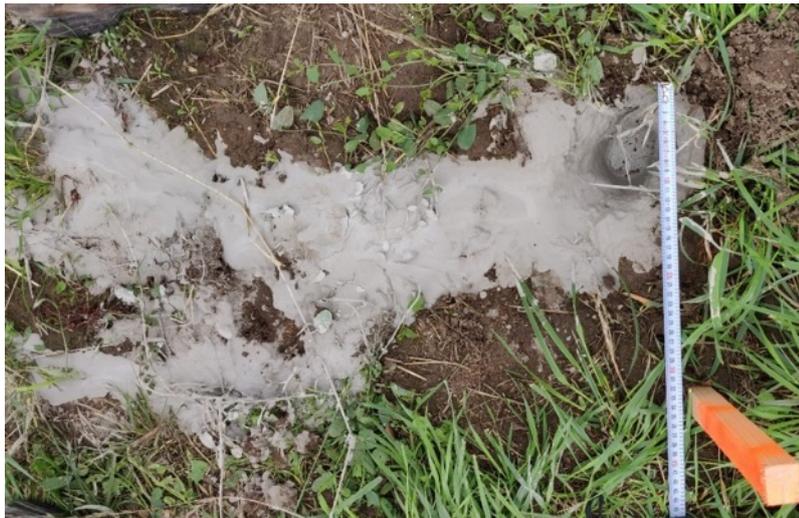
Figure 14 Entry point filled with fast-setting concrete

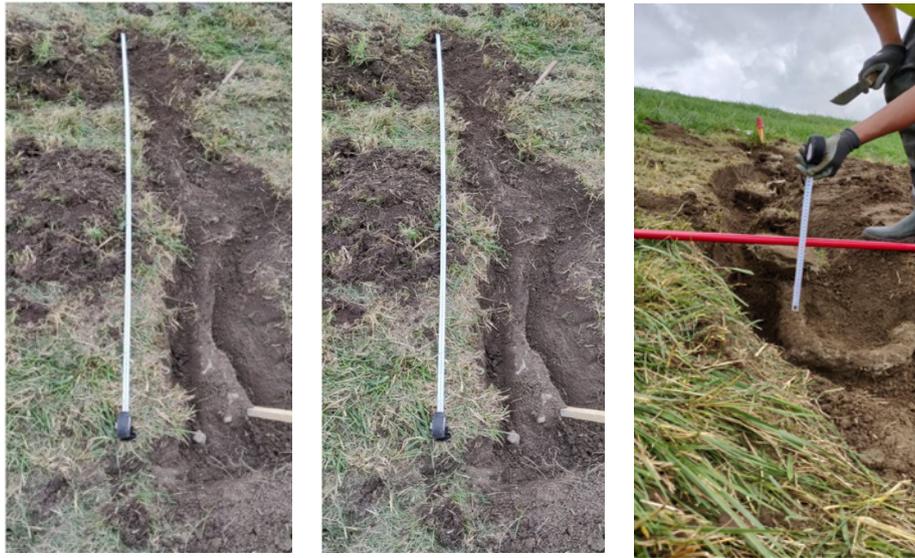
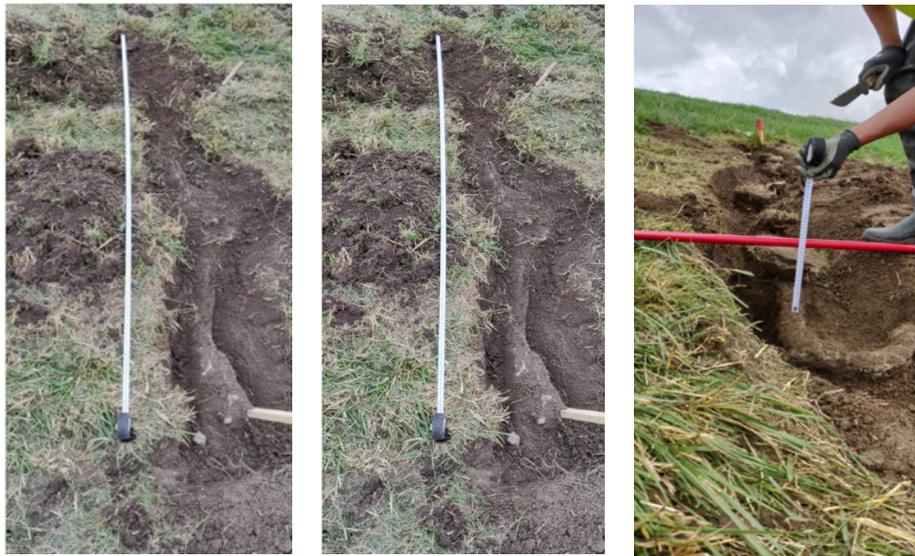
Figure 15 a) Length measurements of focus area b) depth measurements of burrows. c) depth measurements of cracks

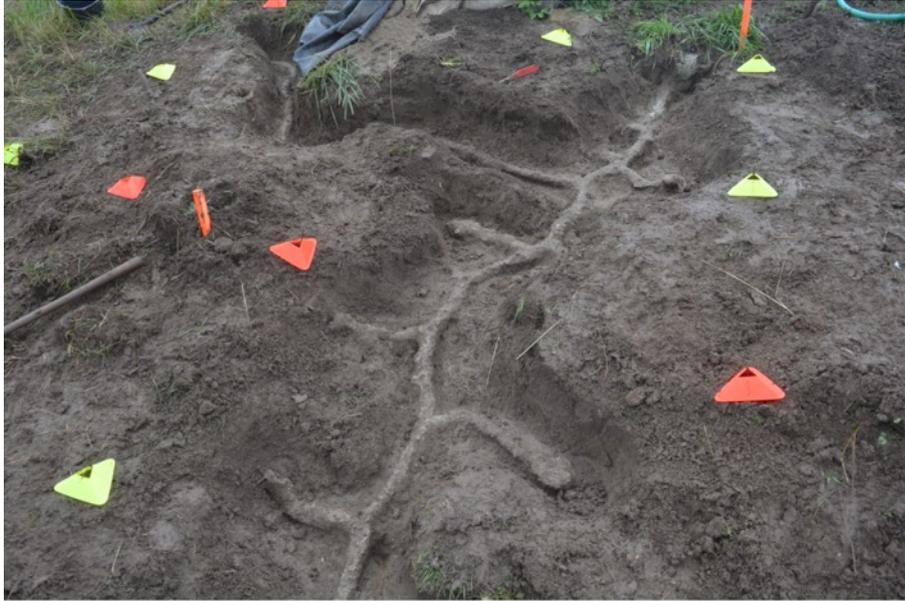
Figure 16 Length depth measurements of mole burrow at Belgian site.

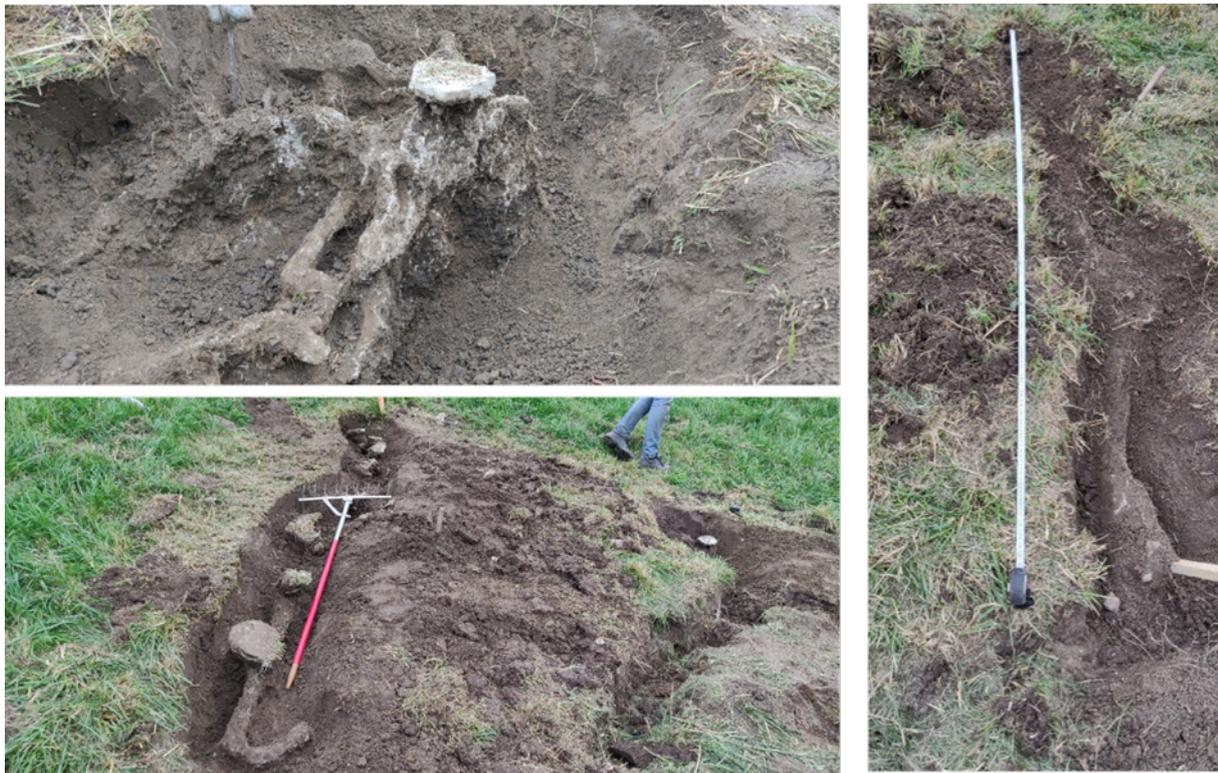
- The mole burrows were situated at a depth of ca. 25 to 30 cm.
- The mole burrows have diameters of 3-5 cm
- The scars/cracks found during the first field visit have been partly disappeared during the second field visit. A probable explanation for this were the change in weather conditions. After a quite long period of relative drought, a longer period of rain fell between the first and second field visit due to which the soil could have swollen again.

Figure 17 Upper left: Hardened concrete was at 50 to 55 cm depth. Because of the combination of cracks and mice burrows the exact depth cannot simply be attributed to either one of them (Focus location The Netherlands 3). Lower left Interrupted concrete structure indicating the recovering of a crack (Focus location The Netherlands 2). Right: Mole burrow longer than 4m ((Focus location The Netherlands 1).

- Next to the mole burrows, cracks and mice burrows were observed. The depth at which hardened concrete was excavated was at a depth of 50 to 55 cm. Because of the combination of cracks and mice burrows the exact depth cannot simply be attributed to either of them [quote of Abel den Boer, made during the field survey].

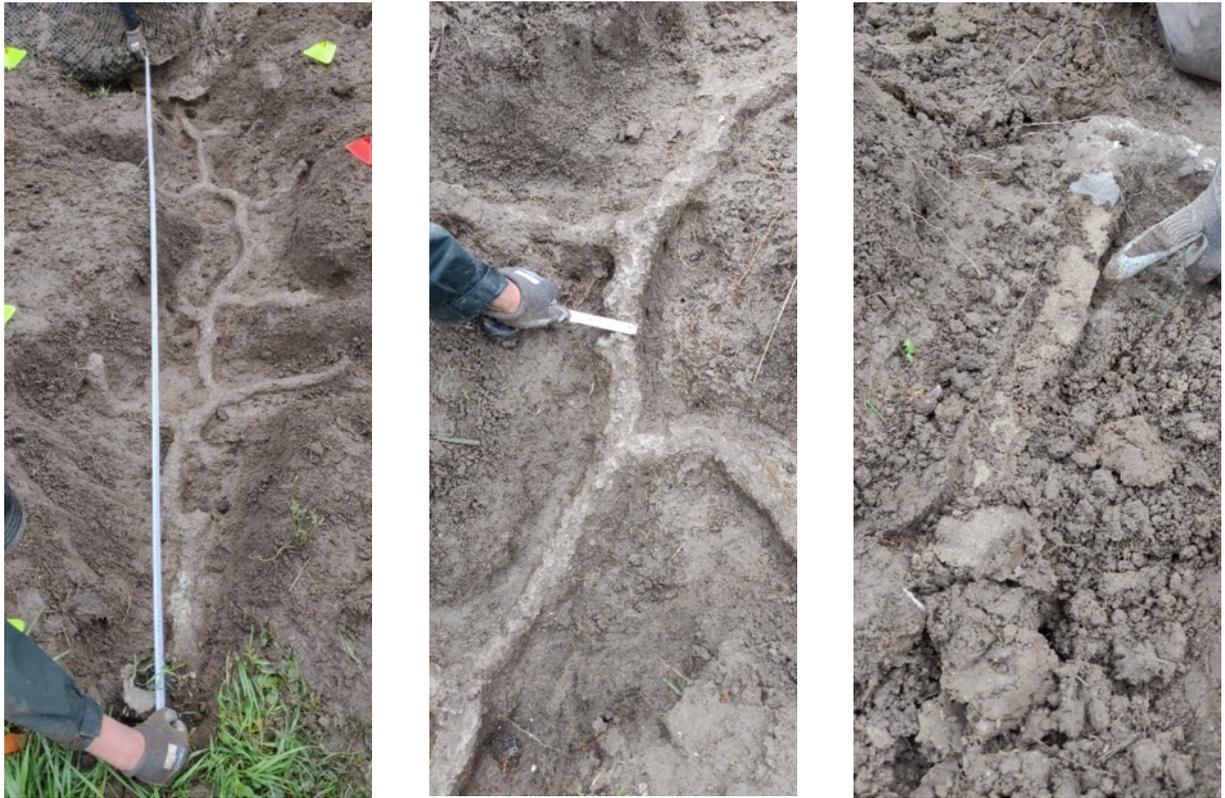
- The mole burrows at the Belgian site location are connected to the sand layer.
- The found mole burrows are at a depth of ca. 25 to 30 cm.
- The maximum linear length of concrete fixed preferential flow path observed was about 3,40 m, which is only a part of the total length of the mole burrow.
- The mole burrows have diameters of 3-5 cm and diameters of 5-8 cm are found.
- The observed mole burrows are interrupted by the placed Rock Bags

Figure 18 Mole burrow at Belgium location a) diameter of mole burrow, b) sandy materials, c) sand layer underneath the mole burrow

- The mole burrows corridors have diameters of 3-5 cm and at the Belgian site location diameters of 5-8 cm are found. It is suspected that the overflow experiments eroded and expanded present mole burrows and corridors.
