# Beaver inspections and repairs for levees

# Why we care about beavers

# Marnewaard exercise in detecting and sealing beaver tunnels

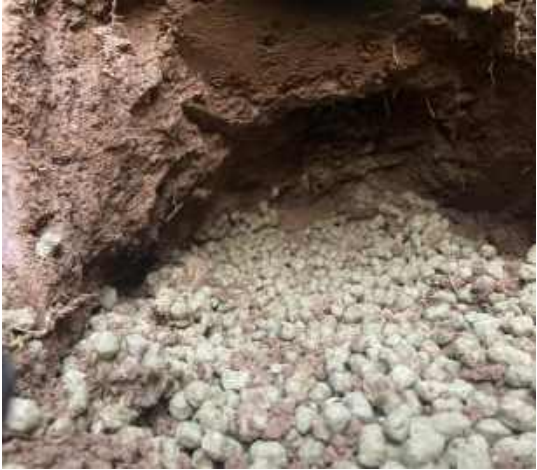
Plugging up holes

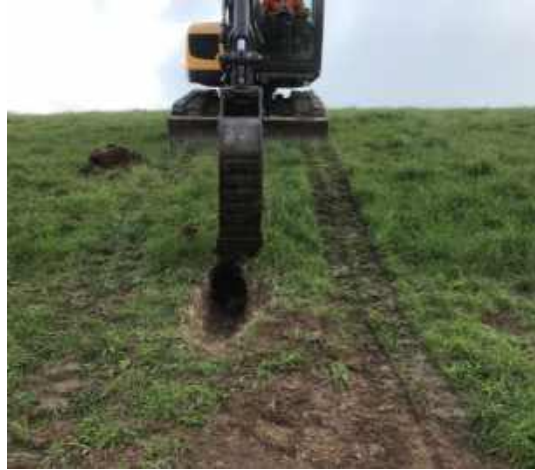
Excavate and refill

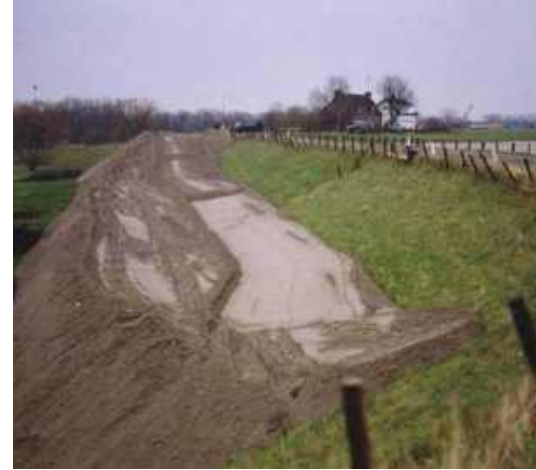
Temporary  
reinforcement

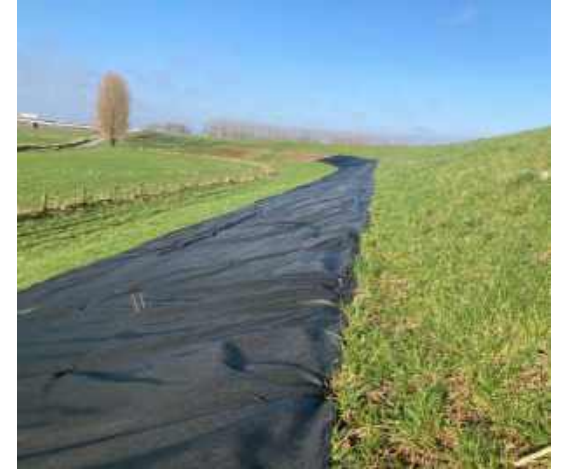
Protect the  
grasscover
