# Impact rapid decrease water level

This Delta Fact was prepared by Deltares, 22 December 2011.

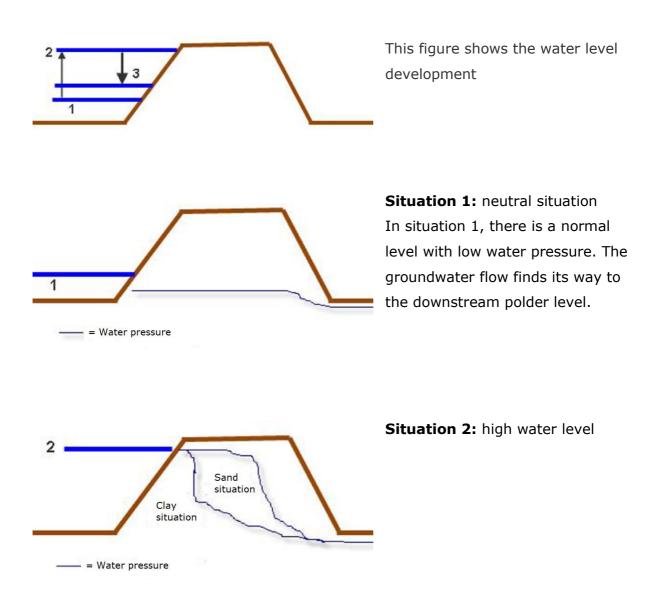
When the water level rises as a result of precipitation or increased water discharge, it creates higher water pressure, causing water to infiltrate the dike and the groundwater to rise to a higher level in the flood defence.

One important factor is the permeability of the dike, which depends on the soil type, where clay is the least permeable, then peat and sand, respectively. The occurrence of shear instability (failure mechanism) is counteracted by the high river or storage basin level. The saturation level of a dike depends on the type of dike due to the complexity of the dike structure.

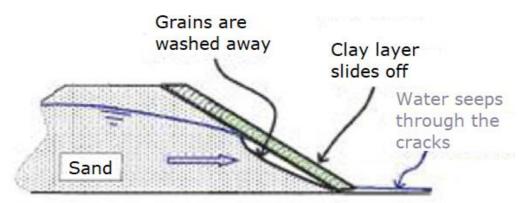
Source: Figure 1.3 from de Groot (2008)

Situation 3: rapid water level decrease

In the event of a rapid decrease in the water level, the infiltrated water drains out of the dike body. The water has created extra weight in the dike and in combination with the water pressure, could cause different failure mechanisms:

- inward instability: large downward movement of a section of soil in response to a slip circle in the slope (situation in Figure 3)
- micro-instability; small-scale erosion of particles (washout). Problems related to micro-instability can occur at both the inner and outer slope.

The following two parameters are leading for situation 3:

- permeability of the dike's soil type in relation to the impact on water pressure level and saturation velocity of the flood defence
- soil strength in relation to impact on landslide

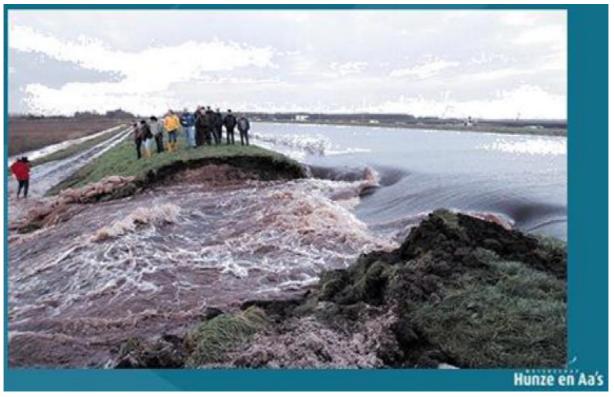
A negative result may be the washout of the canal bed and the damage in the polder. In 1998, in Tussenklappolder, the dike across from the breach nearly collapsed as result of the soil washout, the soil was completely worn away and the toe of the dike across the street was almost torn away. Thus in the new designation the Tussenklopperpolder was not included as a storage area.

Picture of Tussenklappolder ' 98
