LIFE AERFIT

D1 Monitoring end report Apeldoorn – Henk van Tongeren

14 November 2024

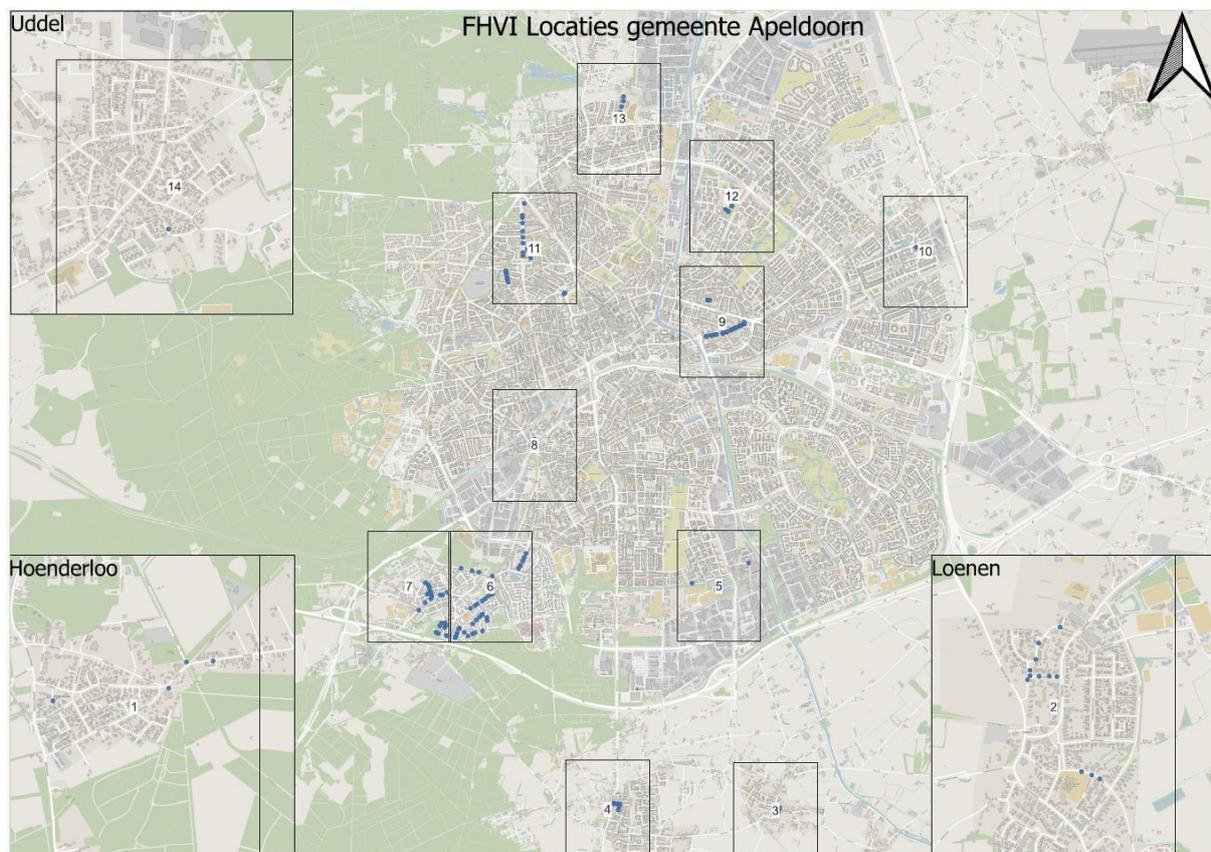
Figure 1. Map with all clusters of installed FHVI-systems in the Municipality of Apeldoorn. See Annex @ for a detailed overview of site locations.

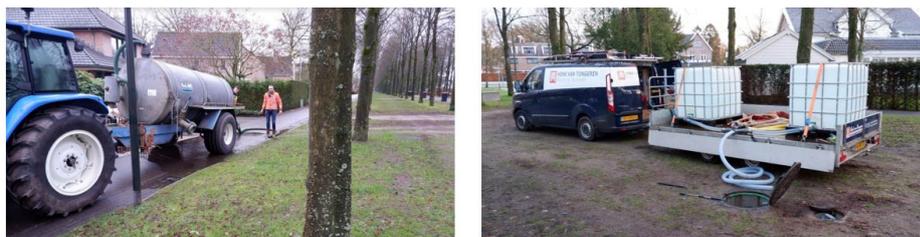
Figure 2. Field tests with on the left the 'street test' for testing the entire system and on the right the 'field test' setup for testing the FHVI.

See Annex 8 for a quick overview of field tests and in Annex 9 reporting on street- and field tests are added. These monitoring test reports are an important basis for the insights in the further design of a simple, robust and durable FHVI-site design. Recommendation and conclusion drawn from the monitoring with field- and street tests can be read in **paragraphs 3.1. and 3.3.**

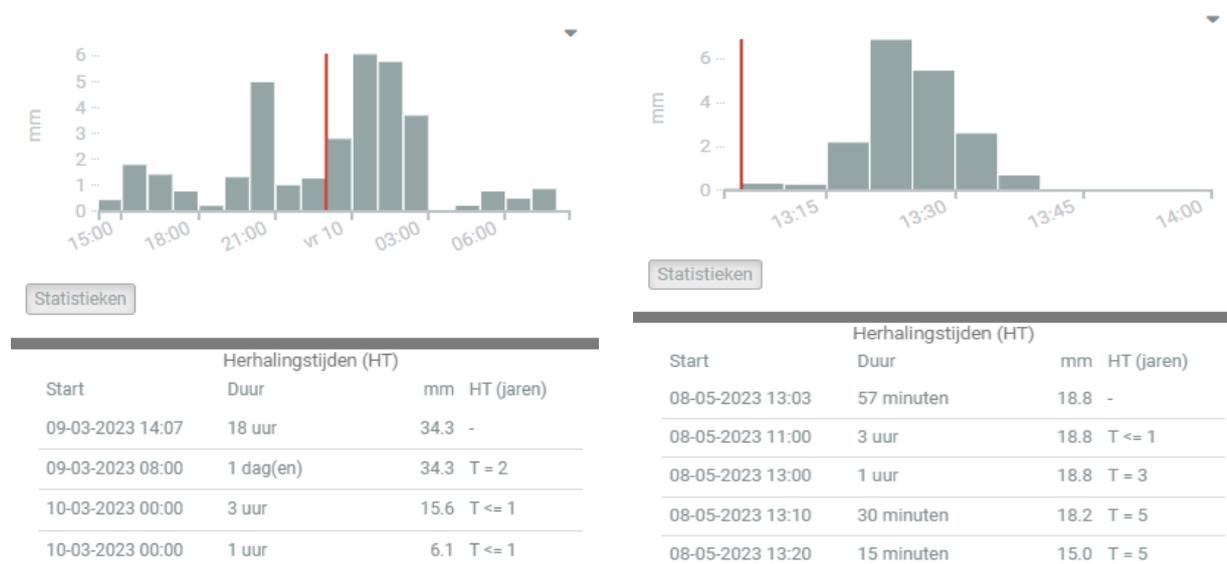
Figure 5. rainfall data of the Dudley and Eunice storms of Februari 2022

Important insights were gained during the Dudley and Eunice storms in February 2022 (below T=5 events), accompanied by very heavy rainfall with reported floods all over the country. AERFIT monitoring data suggested that FHVI infiltrates rainwater rapidly, and water on the flooding street was drained effectively. Figure 6 reflects the monitoring results at the Zwaansprengweg during this time, with reported rainfall of 150mm at some locations, compared to average rainfall of 60mm in February. The figure shows the level of water in the pre-filter with a dark blue line, providing an indication for water on street level. The peaks reflect rainfall, cross referenced by the yellow line representing rainfall in MM/hour from a precipitation meter. The water level in the FHVI is demonstrated by the red line in meters. The peaks with steep vertical blue and red lines, show that the FHVI infiltrates the rainwater rapidly and water on the street is drained.

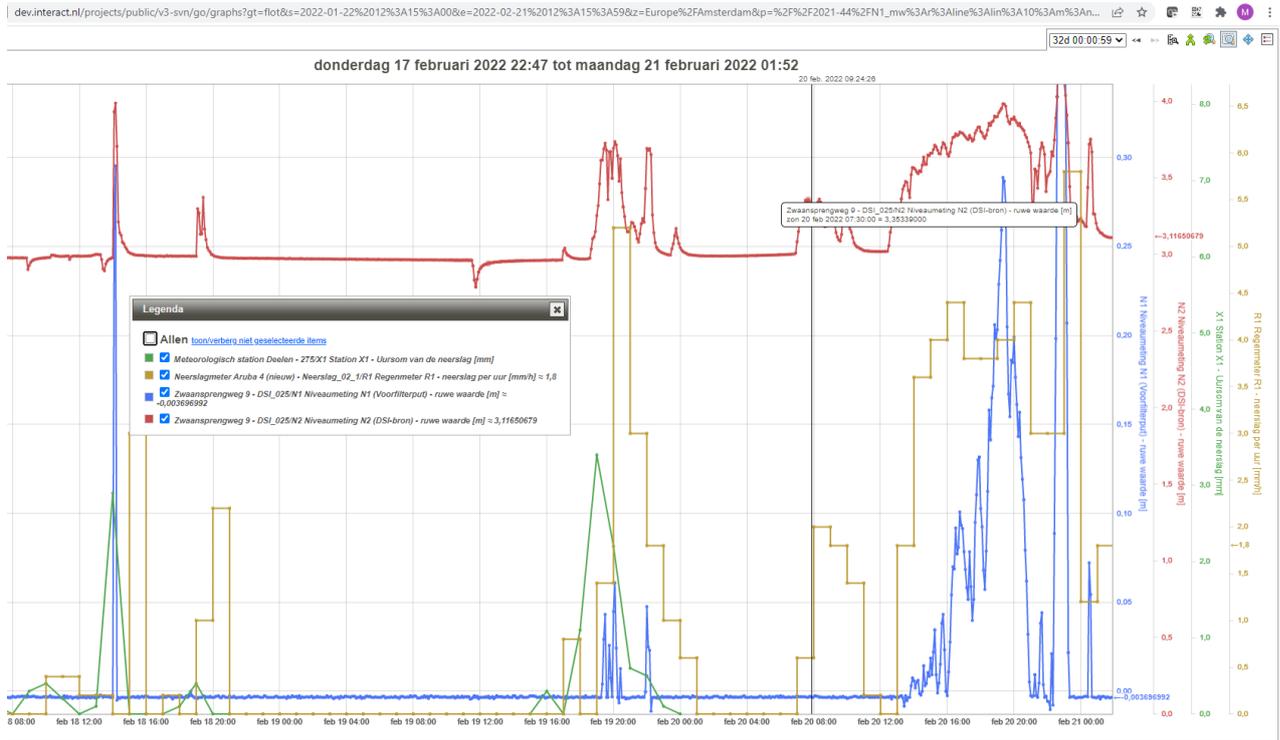
Figure 6 Measurements of the water level at the Zwaansprengweg, 9 during the storms and heavy rainfalls of the 18th until 21th of February. The yellow line represents the rainfall in mm/hour

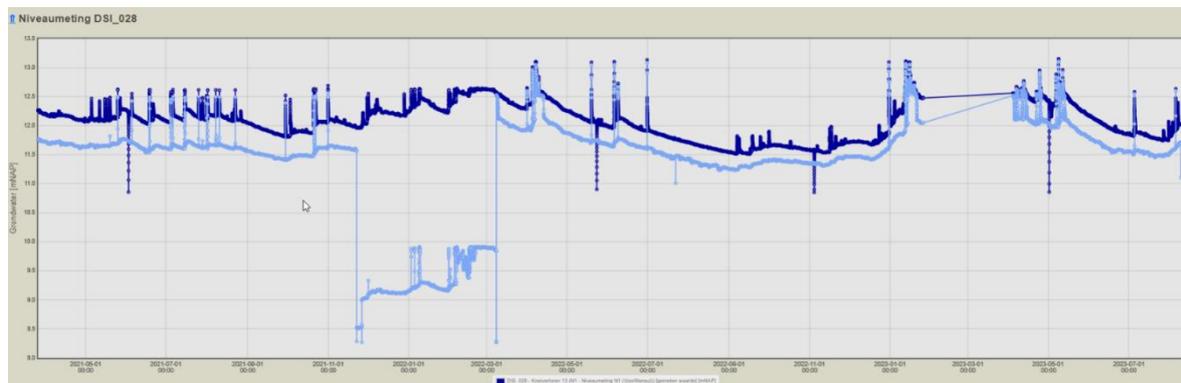
Figure 7 Infiltration capacity at two FHVI wells at Kostverloren from 01-05-2021 to 01-07-2023

This specific data from a single event with heavy rain interval is confirmed with long term monitoring insights throughout the monitoring period see figure 7. In this figure the water level of two FHVI wells at Kostverloren is reflected from Mid-2021 until Mid-2023. Also, here the infiltration rates are reflected by a step rise and decline in the line, indicating that water is infiltrated rapidly and most importantly consistently for a long duration.

The number of not-dissolved particles and their relation to the infiltration capacity over time (hydraulic head measurements and field tests) were measured. FHVI with prefiltration maintains its infiltration capacity. The prefiltration protects the FHVI and moves the risks of blockage to a location which is easier to access for regular maintenance.

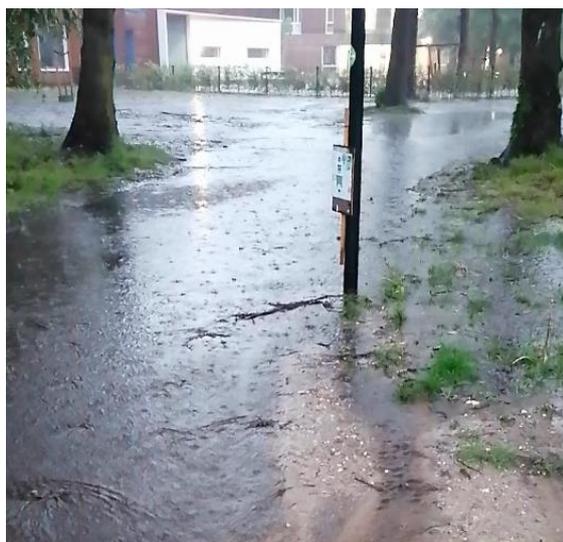
Figure 8. Goto of rainwater runoff in Apeldoorn 10th of march 2023

In 2023, there were regular instances of heavy rainfall. Therefore, this paragraph examines two situations. The first of these occurred on March 10, 2023, where 34.3 mm of rainfall was recorded in 24 hours. This corresponds to a rainfall event of $T = 2$ with a maximum intensity of 6.1 mm/hour. The most intense rainfall event in these months occurred on May 8, 2023. On this date, there was a rainfall event of 18.2 mm in 30 minutes, equating to a $T = 5$. This rainfall event was very localized, so not all FHVI's would have experienced significant rainfall. Two locations did measure this rainfall. These were Zwaansprengweg 9 and Voshuizen 15. Therefore, these locations have been selected for further analysis.

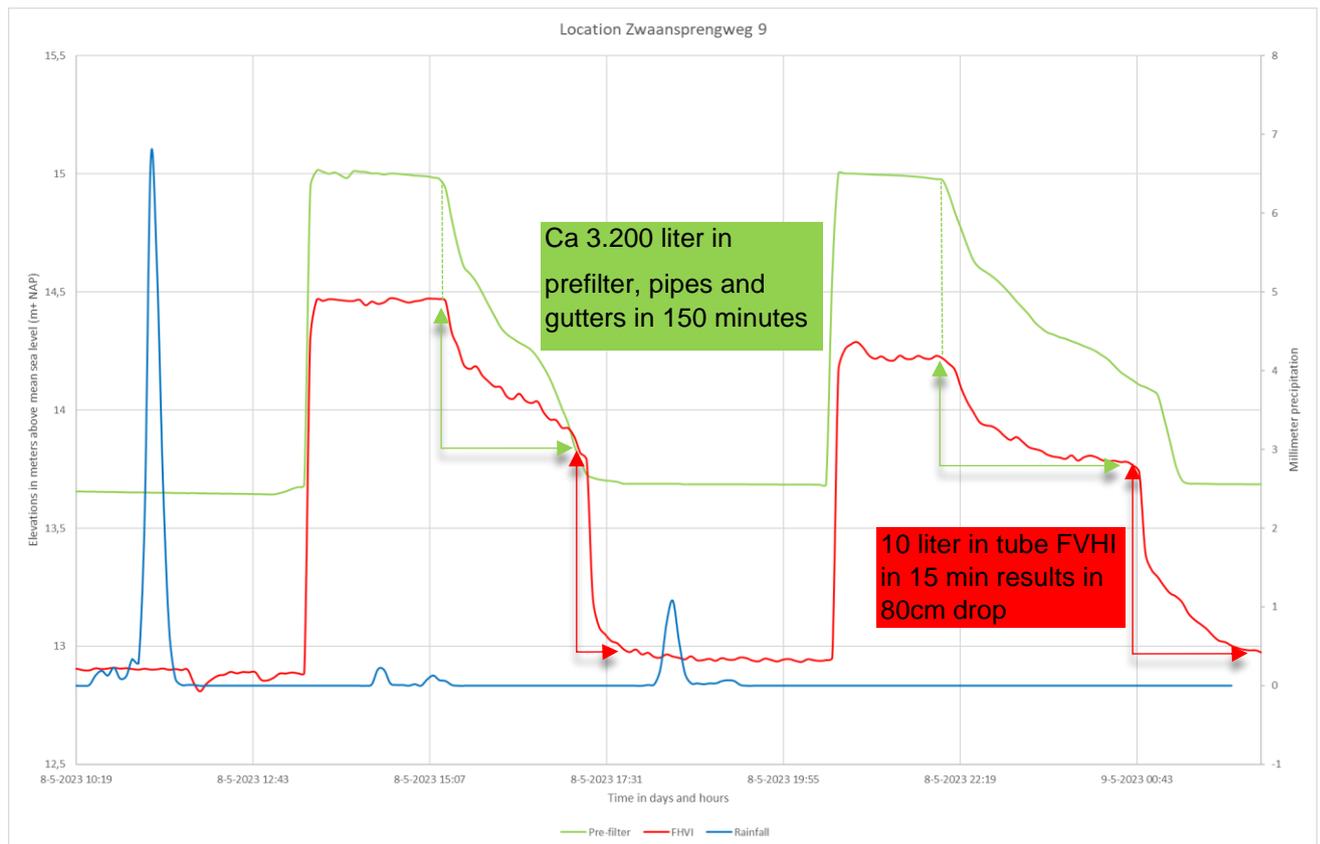
Figure 9. Graph of measured waterlevels 8th may 2023 at Zwaansprengweg 29.

The rainfall on May 8, 2023, was measured at Zwaansprengweg as 15 mm in 15 minutes, which is a $T=5$ rainfall event. Because of extensive experiment at this site with different types of pre-filtration methods this location has a known decreased infiltration rate. This is shown in graph 1 where the water level in the FHVI does not decrease for a long period of time. The water level doesn't decrease because of the slow infiltration rate and because buffered water in the pre-filter and pipes are still flowing into the FHVI. At a water level of 13,80 m+NAP the level drops almost 80 centimeter in fifteen minutes. This steep drop is also approximately the height (precise height is unknown) where water stops flowing into the FHVI. Because of the small diameter of the FHVI the 80 cm drop only equates to about 10 liters of water. The calculation and visualization for this is provided in the visualization below.

With these data we can divide the static storage with time which gives us an infiltration rate in m³/h. With these measurements this is: $\text{Infiltration rate} = 3,26 \text{ m}^3 : 2 \text{ hours and } 30 \text{ minutes} = 1,3 \text{ m}^3/\text{h}$. This is in line with the amount of infiltration measured in field test in 2023. In this field test performed in August 2023 (3 months after this rainfall) gave an infiltration rate of 0,9 m³/h. After this test the FHVI

and pre-filter were cleaned and the field-test was done again. The infiltration rate for this test was 2,2 m³/h.

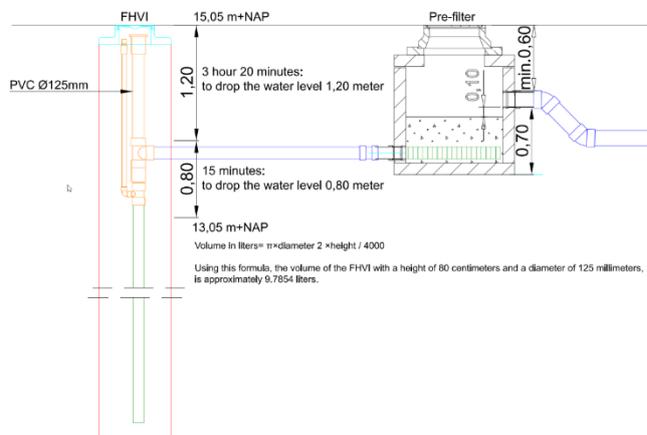
Figure 10. Pre-filter HWZI

The location of Zwaansprengweg 9 has a pre-filter type HWZI. About 90 percent of volume in the system can discharge in to the FHVI. The rest can exit the bottom of the pre-filter via two holes in the concrete.

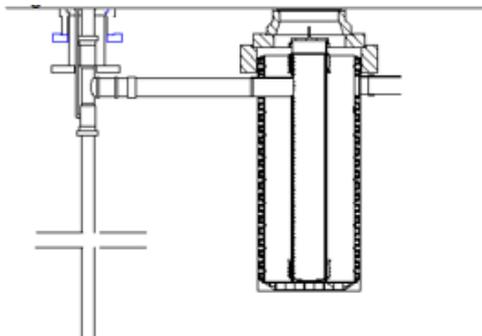
Figure 11. Pre-filter Wavin-Apeldoorn

At Voshuizen 15, the pre-filter is the type Wavin-Apeldoorn. The pre-filter can not fully empty in to the FHVI. The housing of the pre-filter is a vertical placed infiltration pipe: water can infiltrate thus the surrounding soil.

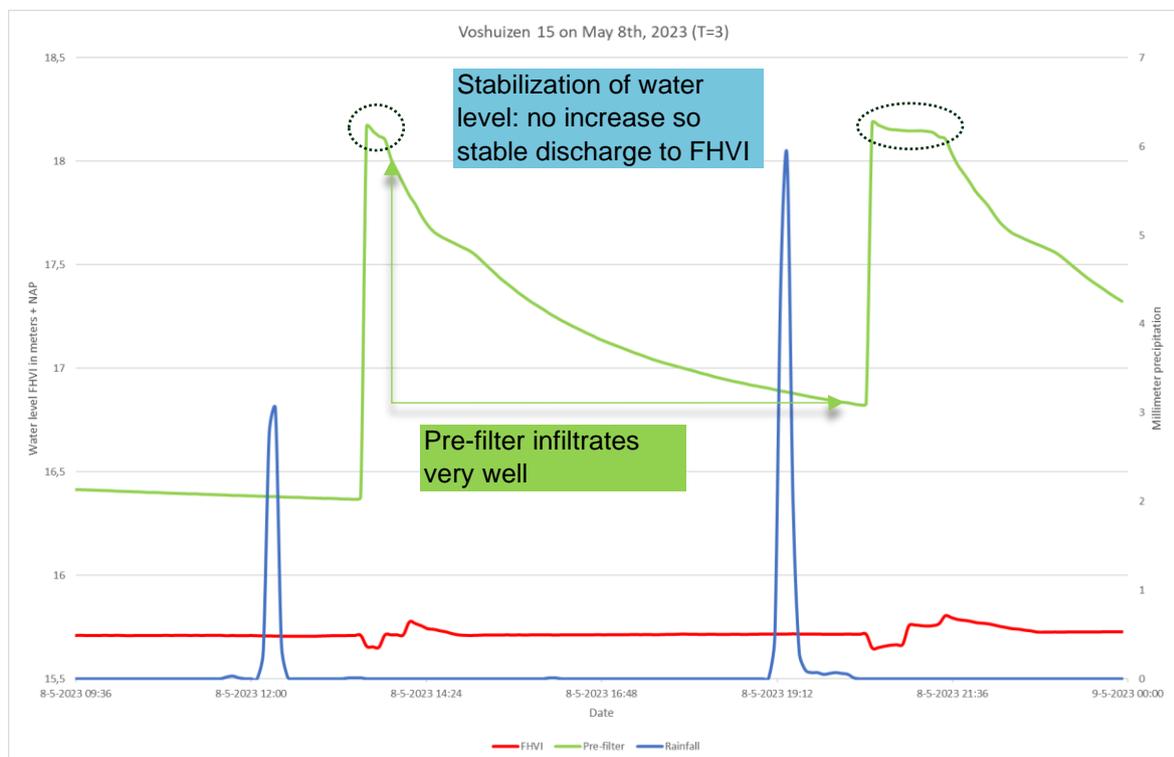
Figure 12. Graph of measured water levels 8th may 2023 at Zwaansprengweg 29.

The rainfall on May 8, 2023, was measured at Voshuizen 15 as 12 mm in 15 minutes, which is a T=3 rainfall event. This event is only slightly visible in the FHVI. However, they are clearly visible in the pre-filter. It is also noticeable that the water level seems to drop in the FHVI initially. The cause is unknown at this moment. We now think this is likely an error in the measurements due to te set-up of the water level meter and how air pressure compensation sensor is placed in this measuring devise. A similar problem occurred on the location Zwaansprengweg. Here a second water level set-up was installed with has the air-pressure sensor placed outside of the FHVI-well.

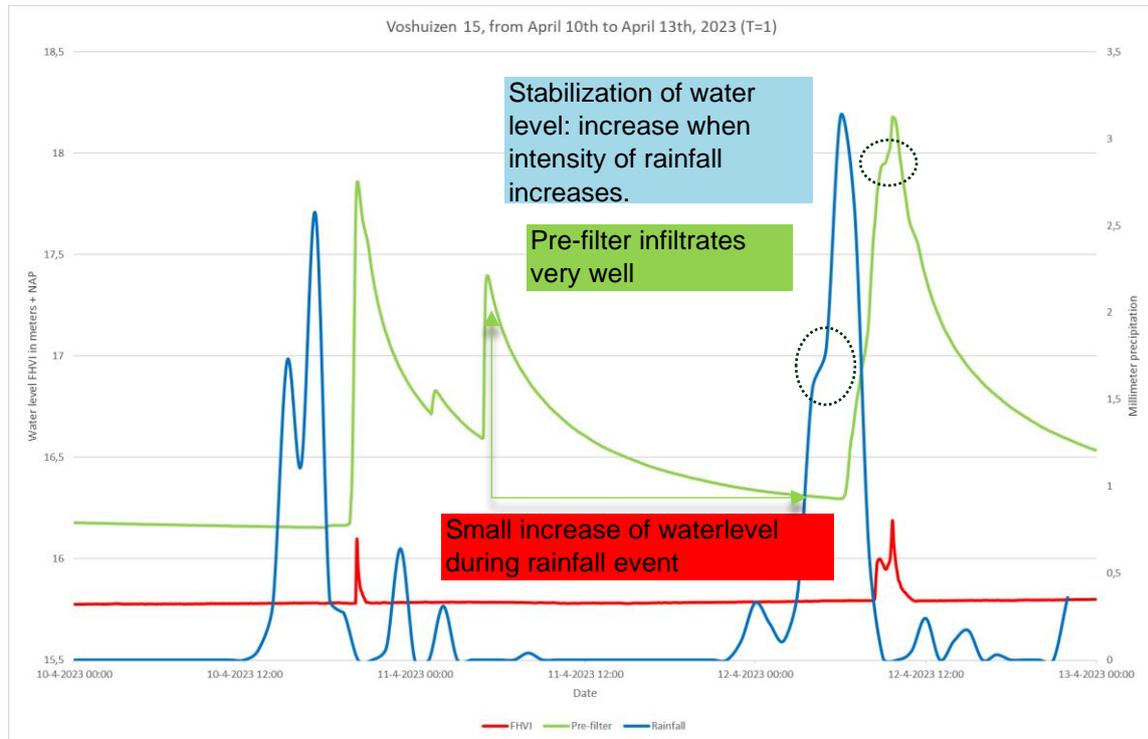
Figure 13. Graph of measured water levels 10 and 11th April 2023 Voshuizen.

The heaviest recorded downpour in the FHVI occurred on April 10, 2023. This increase of the water table in the FHVI was relatively small, with only 20 cm. The downpour on April 12, 2023, had a similar intensity and measurement in the FHVI. Therefore, these two downpours are easily compared with each other. This shows that a certain downpour event is preferred for the analysis of the effectiveness of a specific FHVI-system.

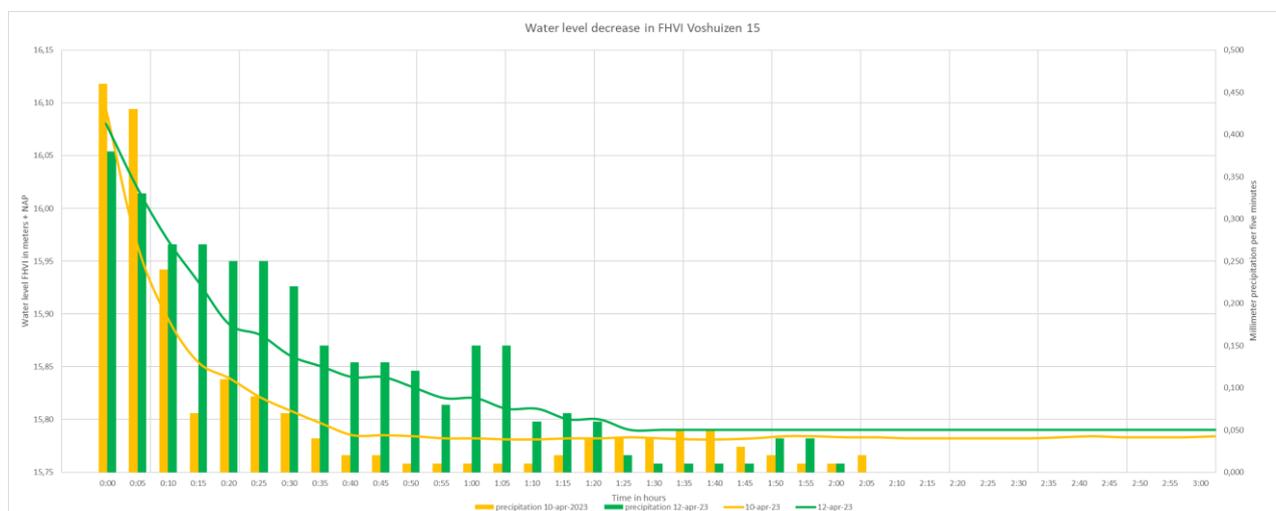
Figure 14. Graph of measured waterlevels 10th April 2023 Voshuizen.

If we then zoom in on the downpours, it is visible that the downpour on April 10, 2023 (yellow line), infiltrates in 40 minutes. The downpour on April 12, 2023, infiltrates in approximately 45 minutes, but then keeps slowly decreasing until about 1 hour and 30 minutes (green line). When we compare the precipitation data with these figures, it becomes clear why. The downpour on April 10, 2023, has a sharp peak but then almost immediately stops (yellow bar). The downpour on April 12, 2023, lasts longer and has a fairly stable intensity (green bar). As a result, rainwater enters the FHVI for a longer period, which muddles the measurement.

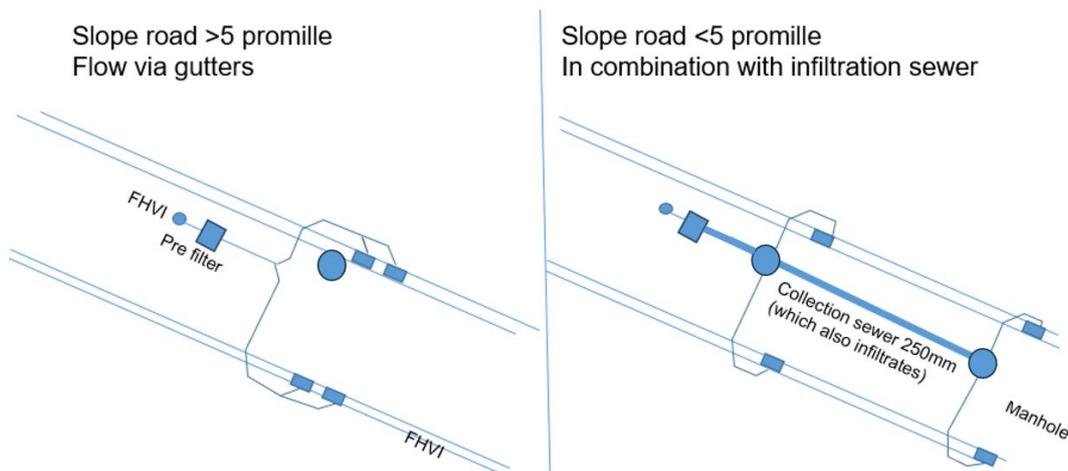
Figure 15. Schematic design of FHVI-water collection layout

Following further experiences in the field during the operation, several new refinements were made in the design. A general conclusion of the project design is that customization is often needed, based on the different challenges in the field, related to the ground water table, soil composition and clogging. The partners are currently developing a 'menu' for municipalities that provides different designs for different circumstances and street levels in the field in order to facilitate the after-LIFE phase. Basic guidelines for use of FHVI at street level are (see also figure 6):

- 5-10 m³/u per FHVI-system is starting point. If this succeeds, it can be used as input for design.
- Area (for example 400m²) or rainfall events is not input for the capacity of one FHVI-system, but determines the amount needed.

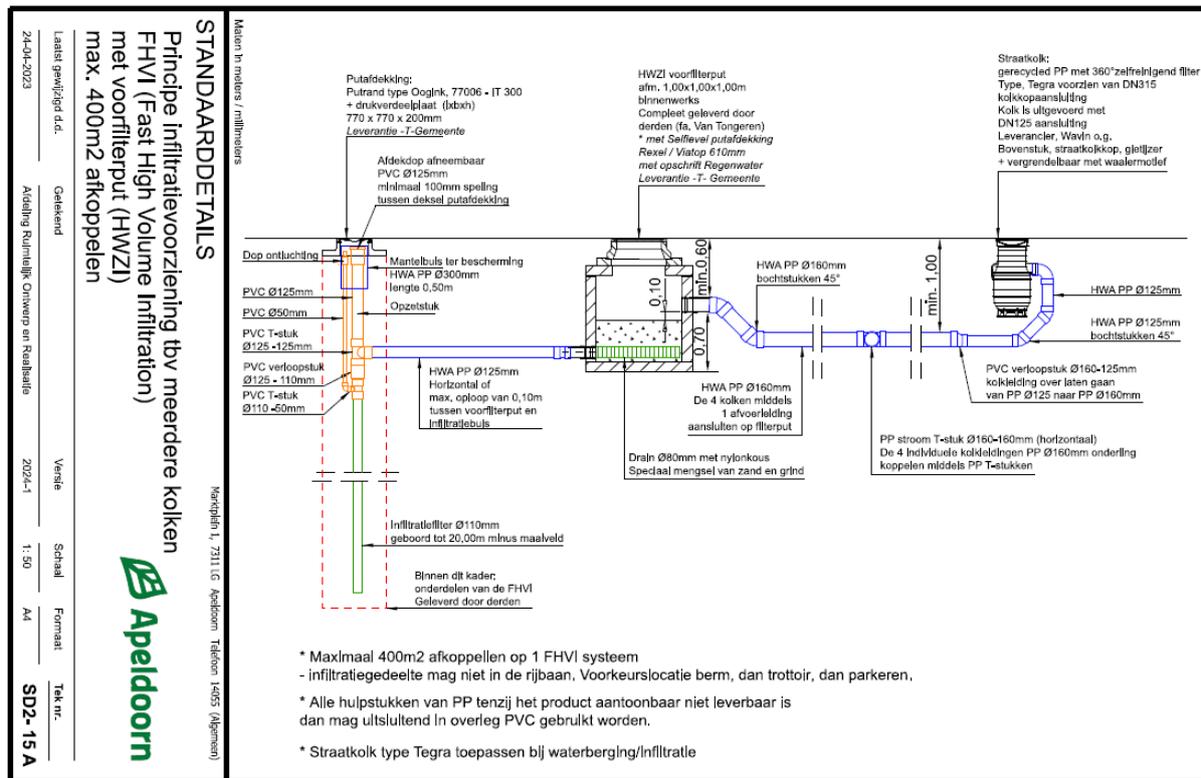
Figure 16.. Principle design of FHVI piping in combination with HWZI. Image x. Principle of elaboration of FHVI piping in combination with HWZI.

When installing the HWZI as a pre-filtration, the FHVI will keep its infiltration capacity. The HWZI protects the infiltration-system and moves the risks of blockage to a location which is easier to access.

Footnote: the HWZI itself seems (relatively) not vulnerable for blockage. See also **Annex 4** for the blue print of a FHVI-site with HWZI-prefilter.

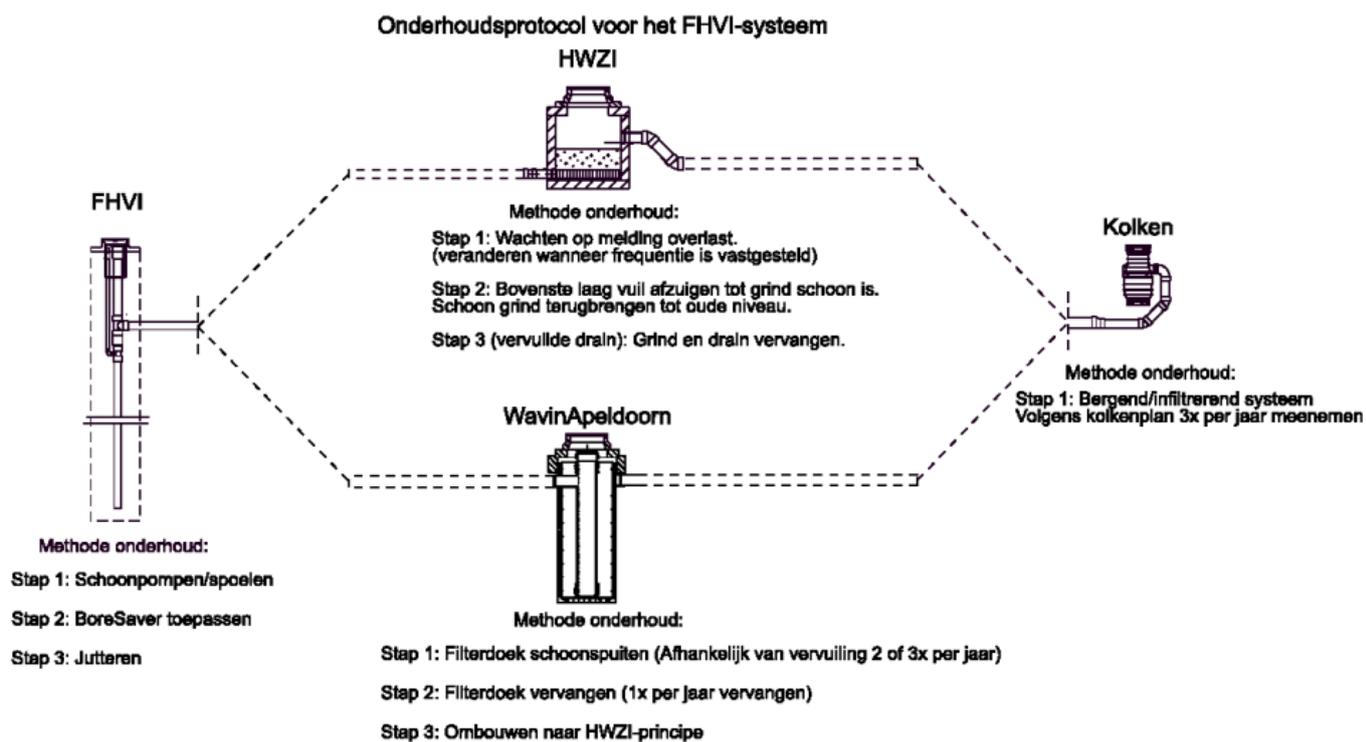
Figure 17. Schematic overview of the maintenance protocol with different protocols for the FHVI (left) and two prefilter options (middle).

On top of this a maintenance protocol was designed for the FHVI systems and a re-design of the pre-filter for the pre-treatment stage was carried out to tackle the problem of clogging of the pre-filter (see fig. 5).

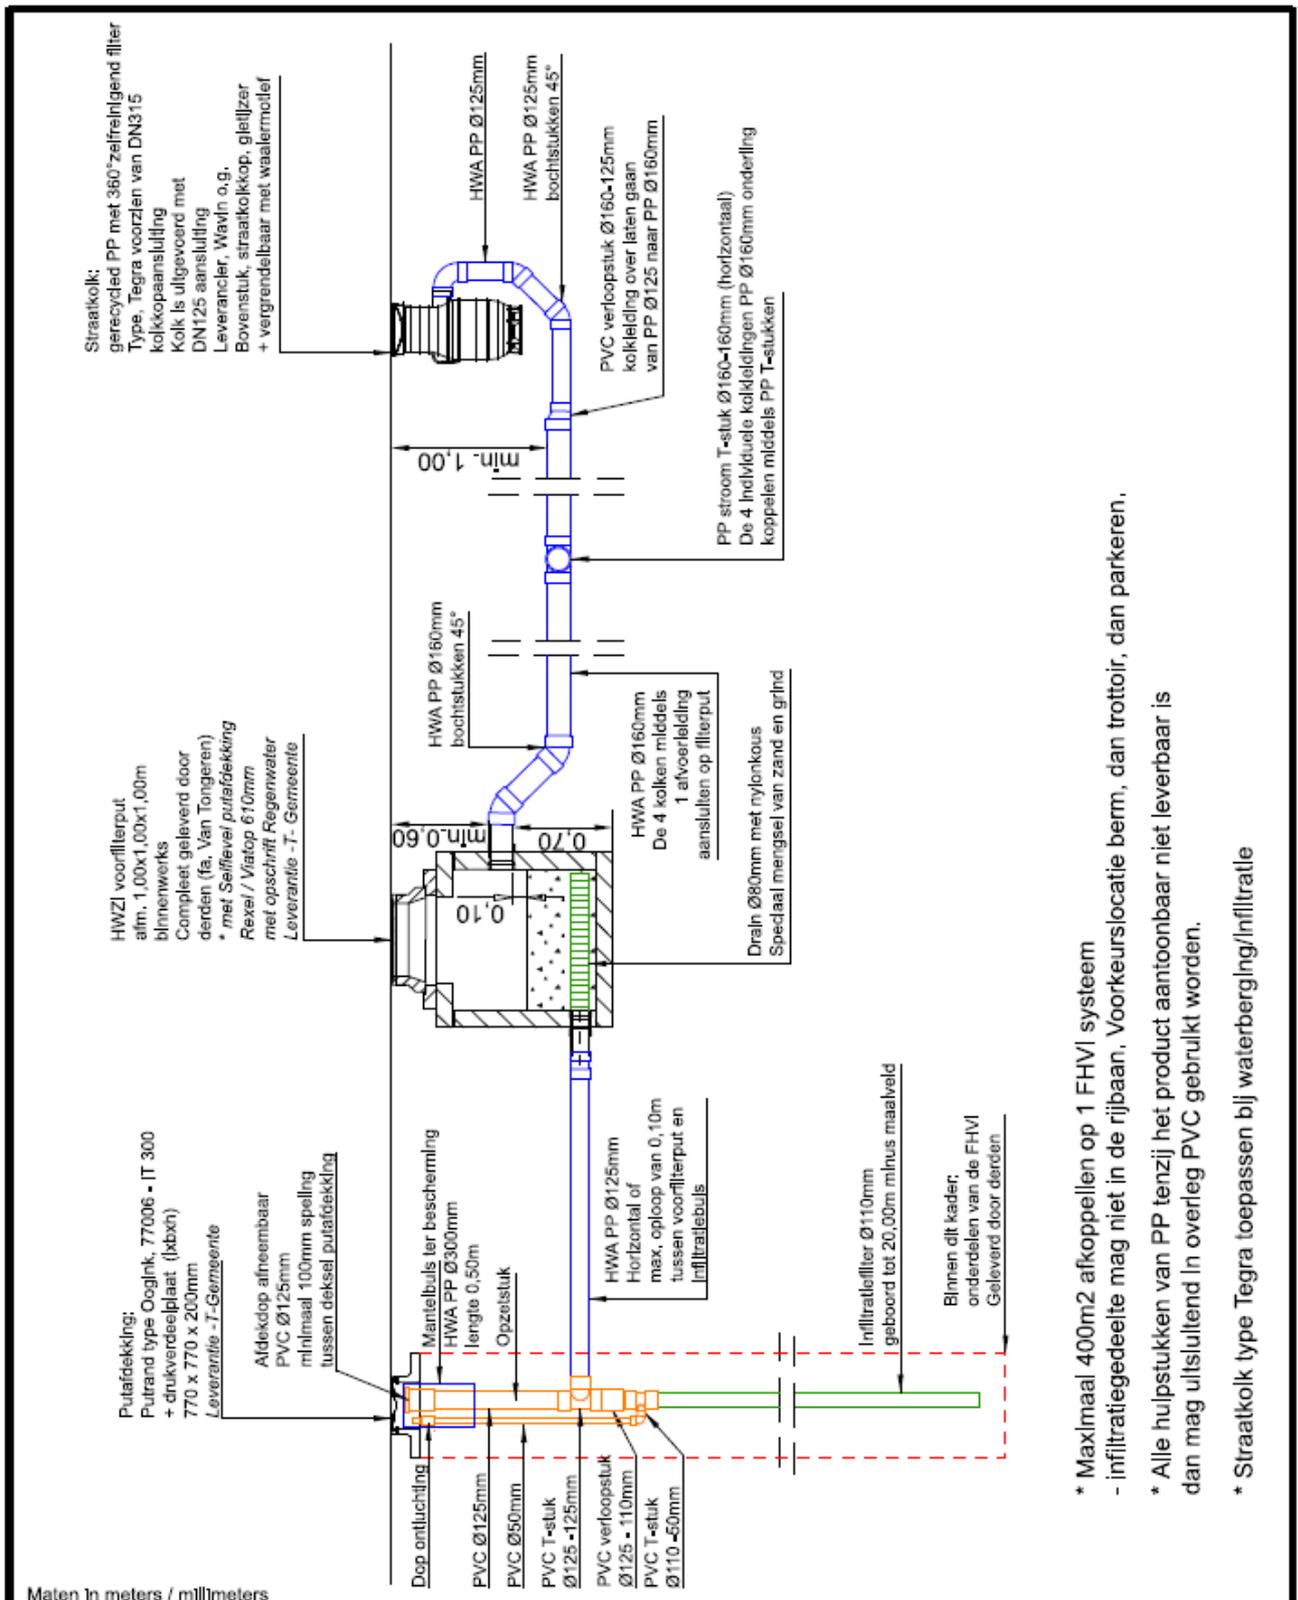
- * Maximaal 400m² afkoppelen op 1 FHVI systeem
- infiltratiegedeelte mag niet in de rijbaan, Voorkeurslocatie berm, dan trottoir, dan parkeren.
- * Alle hulpstukken van PP tenzij het product aantoonbaar niet leverbaar is dan mag uitsluitend in overleg PVC gebruikt worden.
- * Straatkolk type Tegra toepassen bij waterberging/infiltratie

Principe infiltratievoorziening tbv meerdere kolken
FHVI (Fast High Volume Infiltration)
met voorfilterput (HWZI)
max. 400m² afkoppelen
