LIFE AERFIT

D1 Monitoring end report Apeldoorn – Henk van Tongeren

14 November 2024

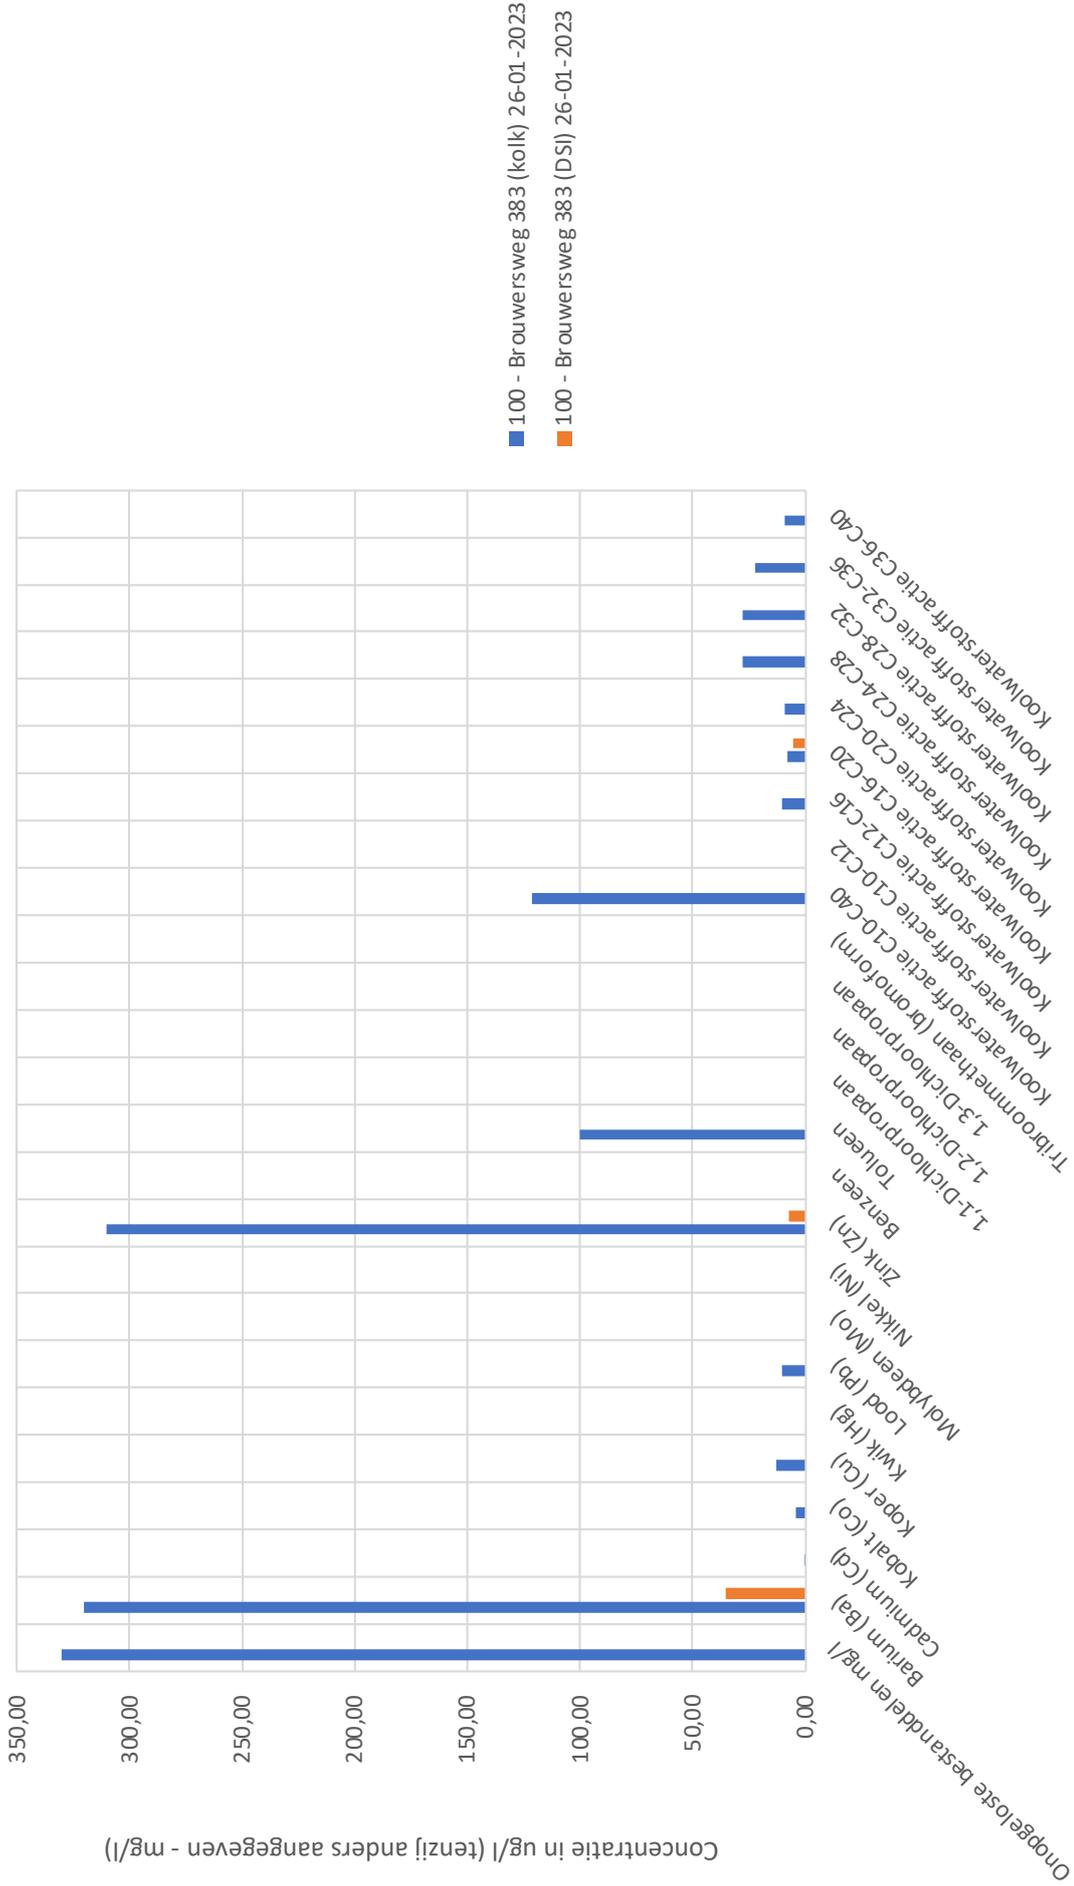
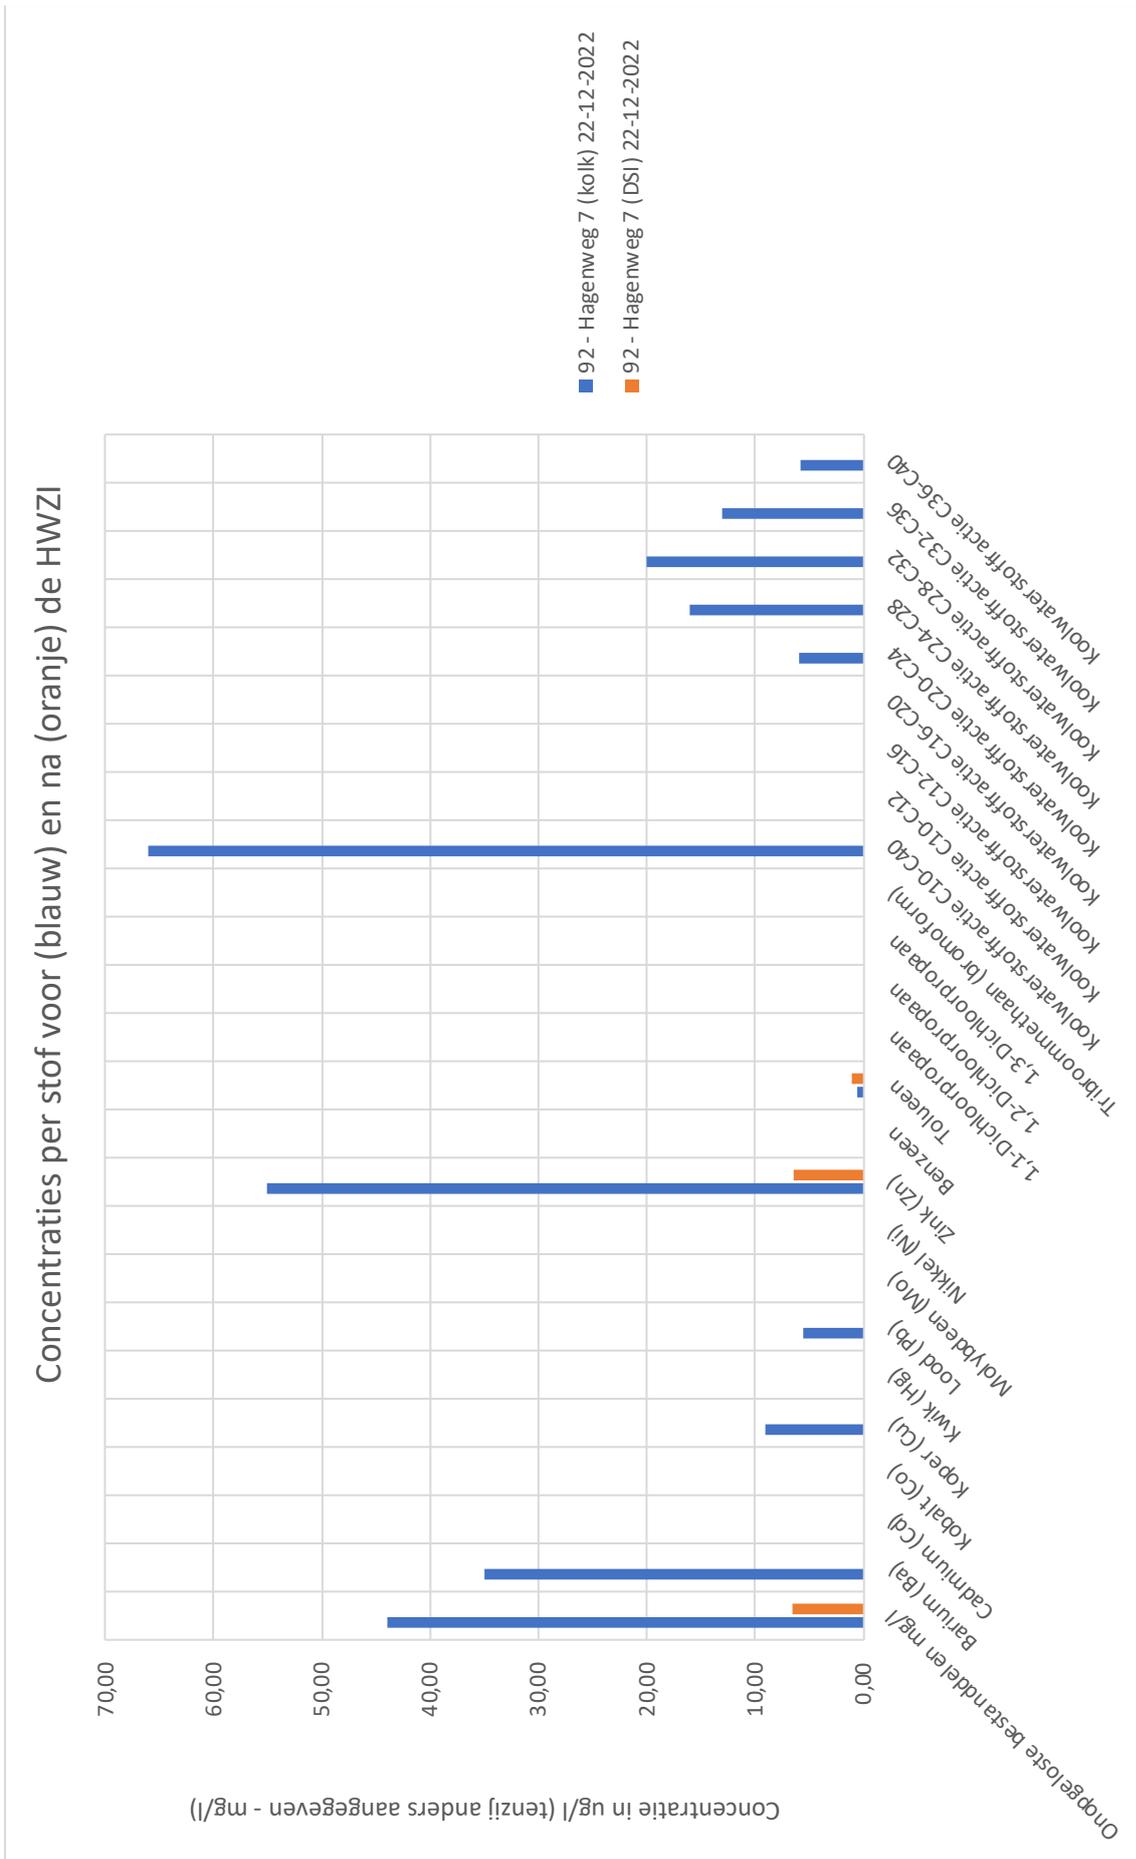
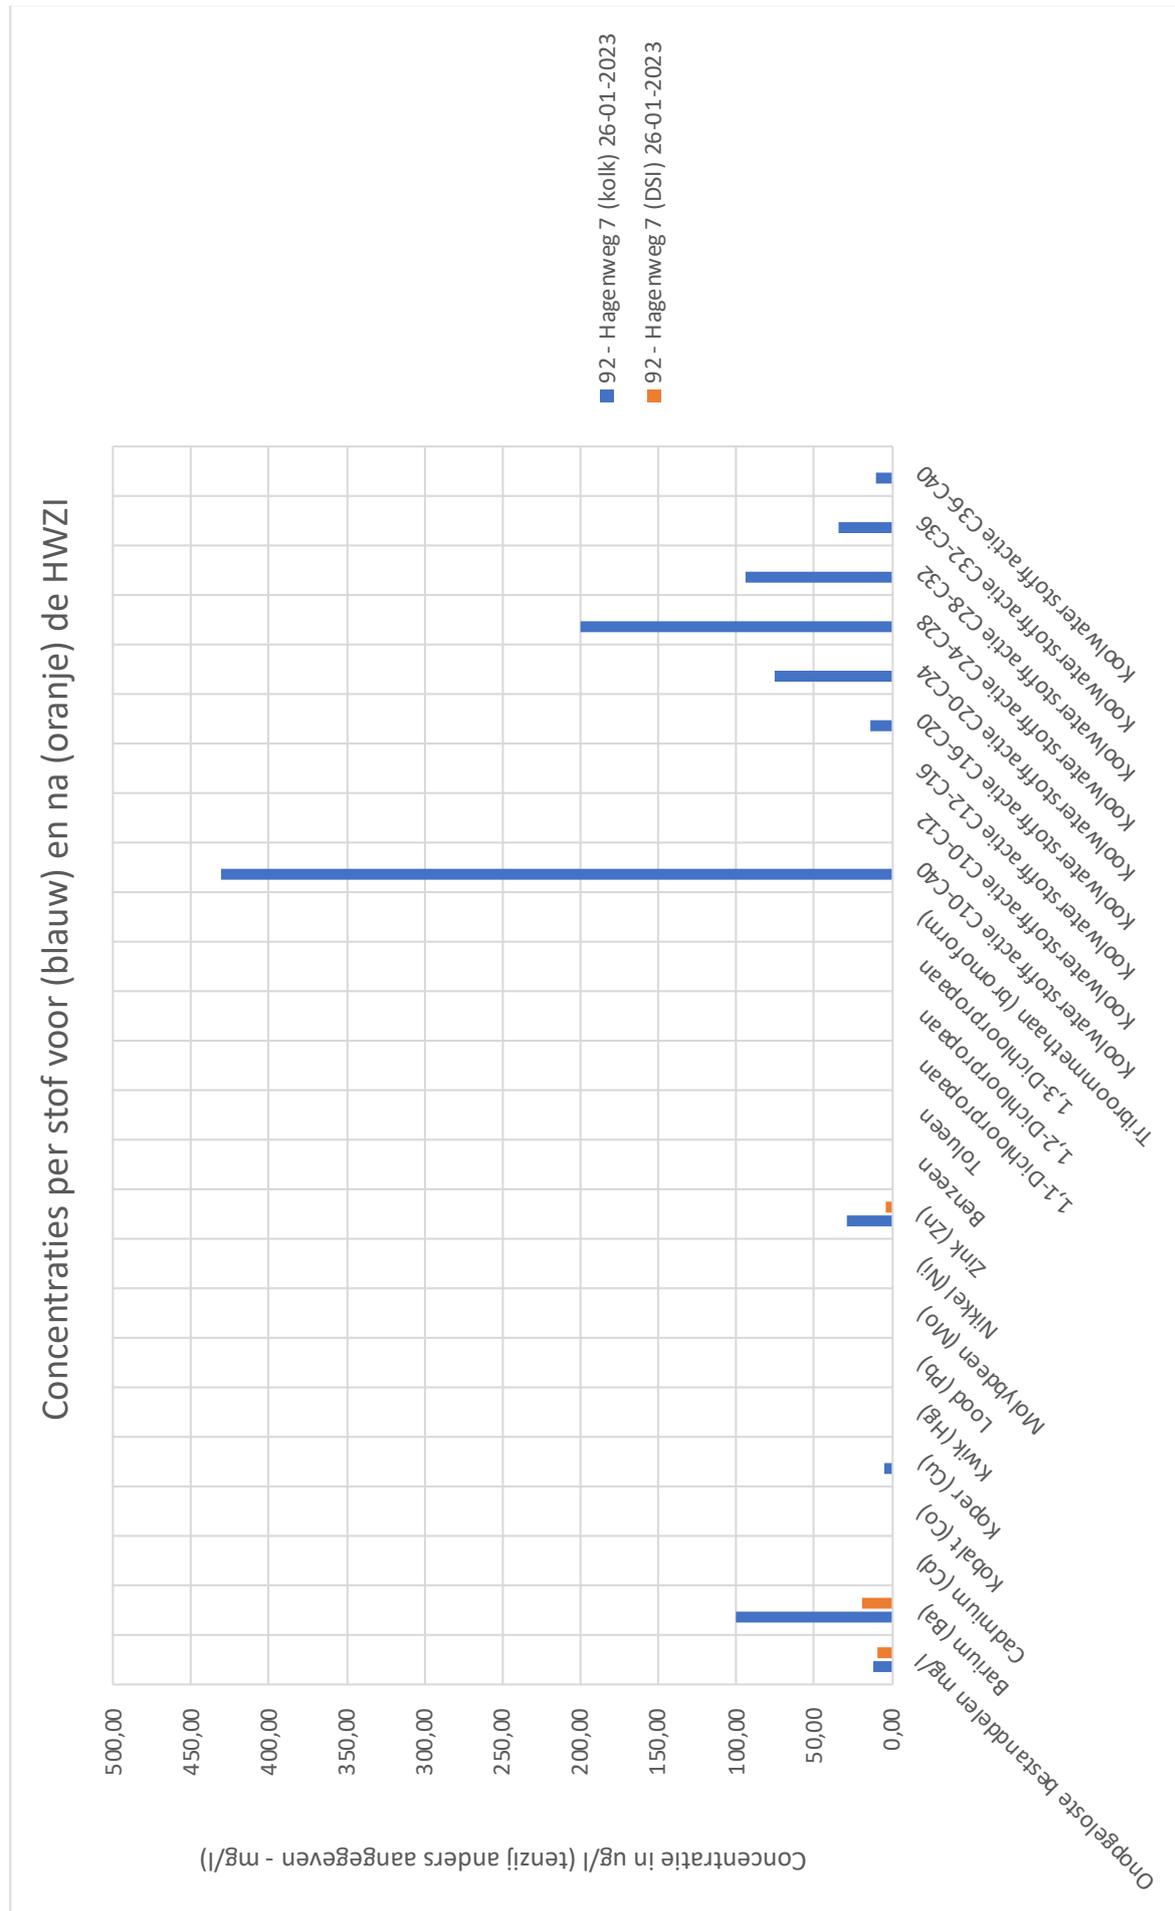
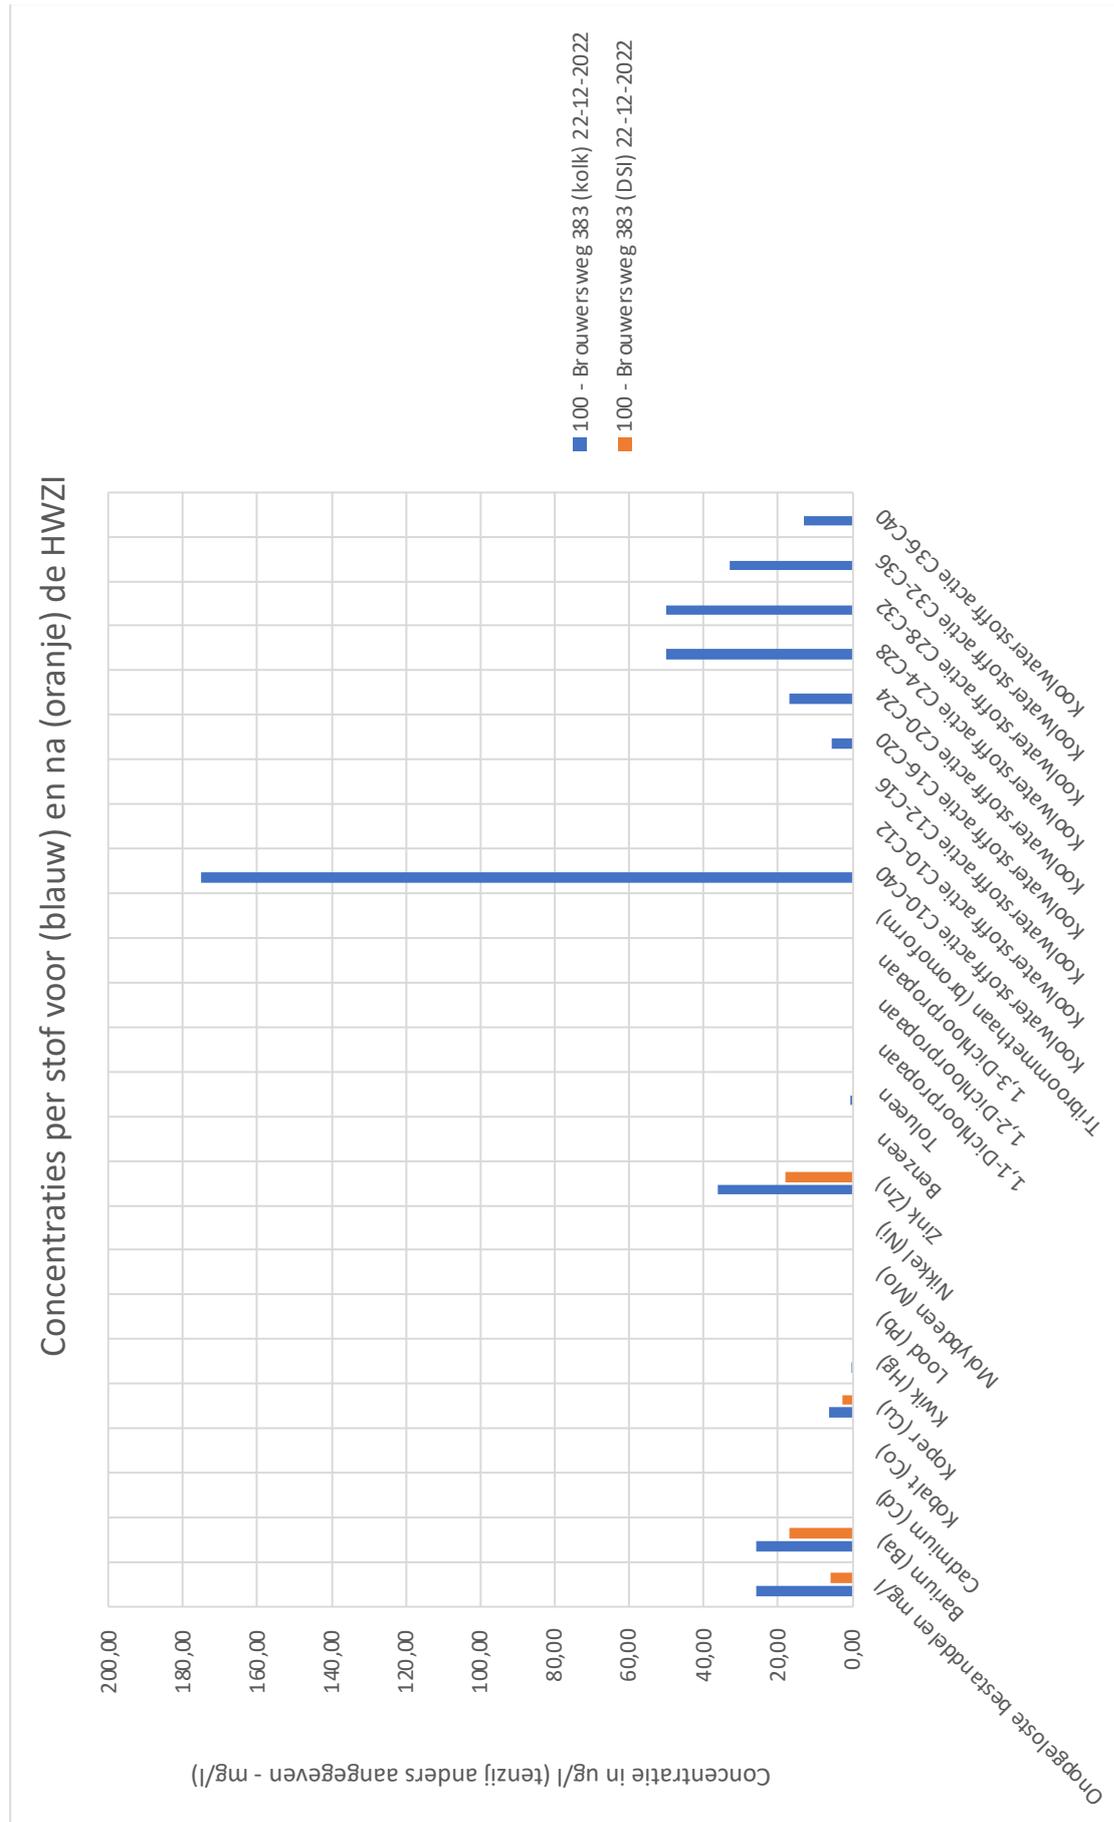
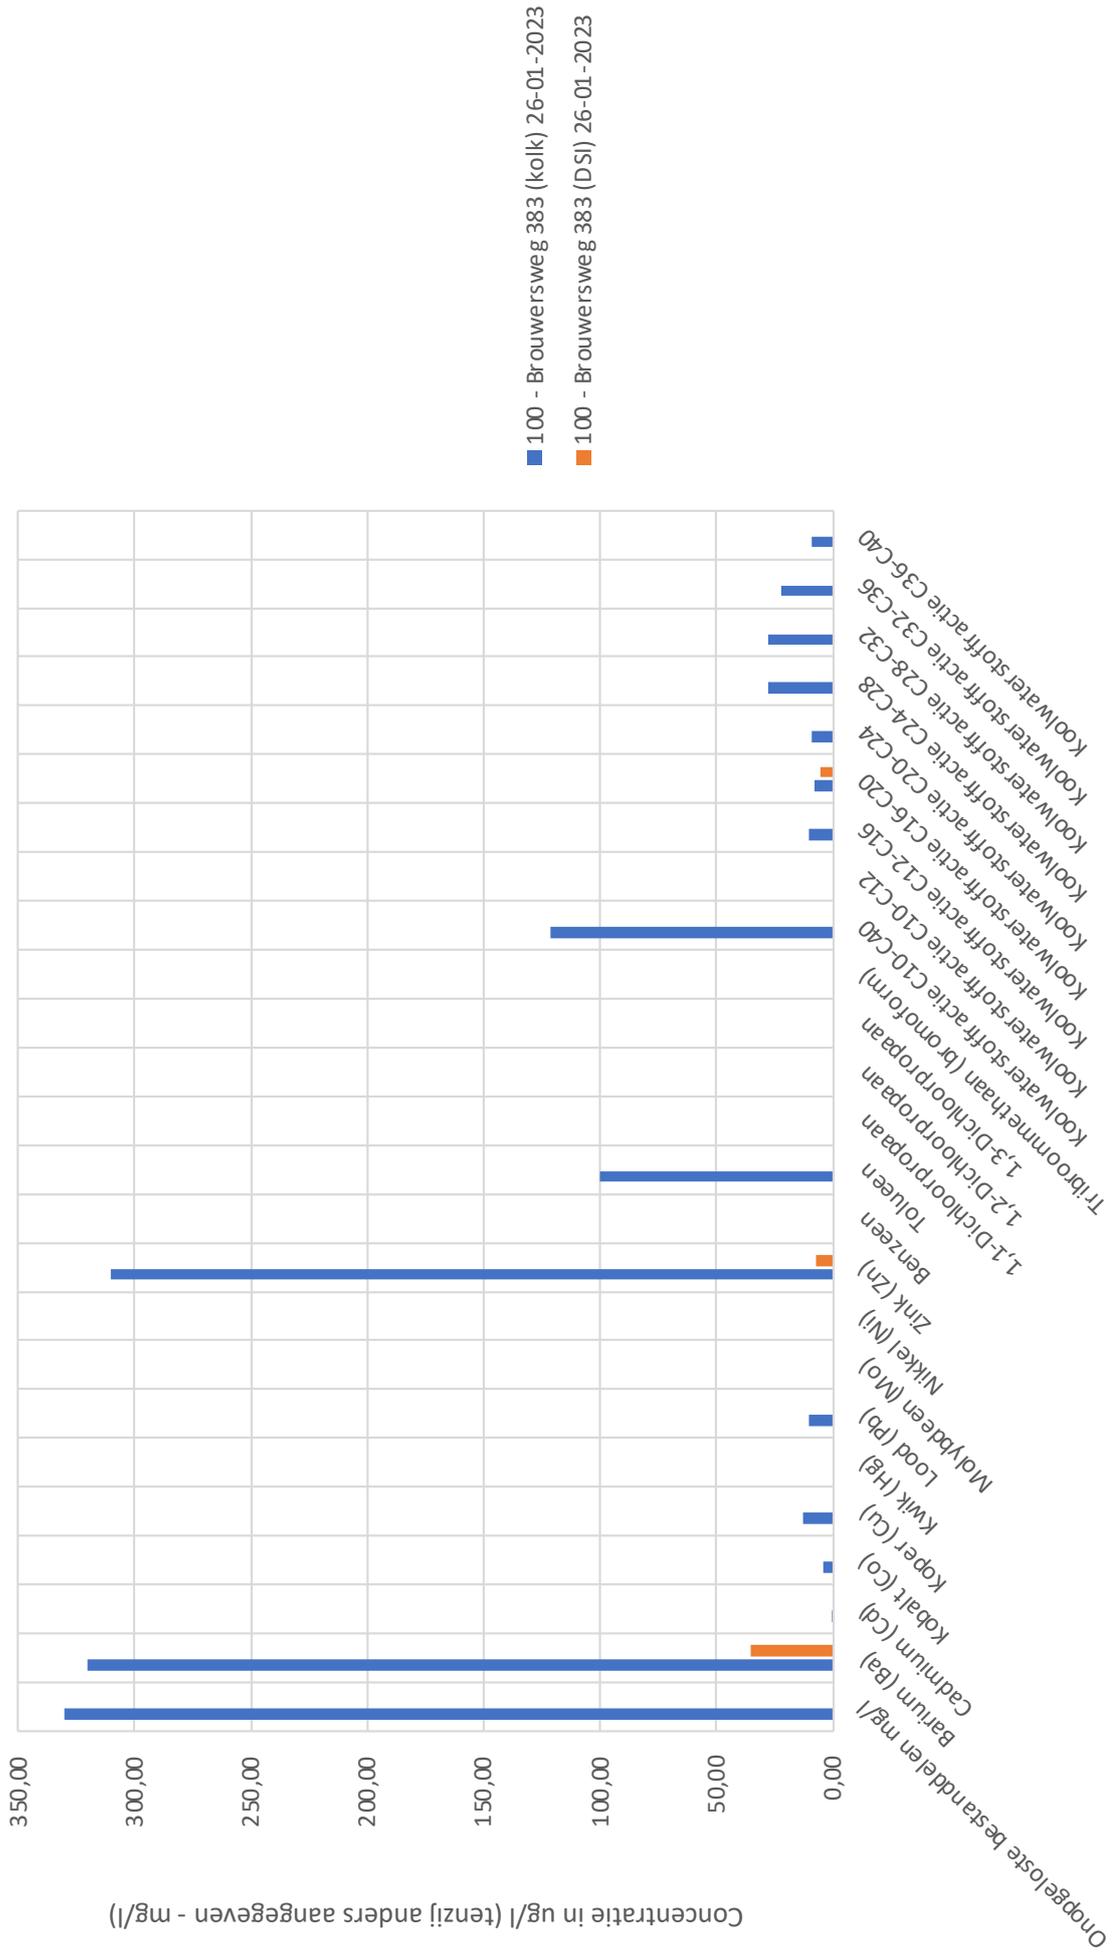
Concentraties per stof voor (blauw) en na (oranje) de HWZI

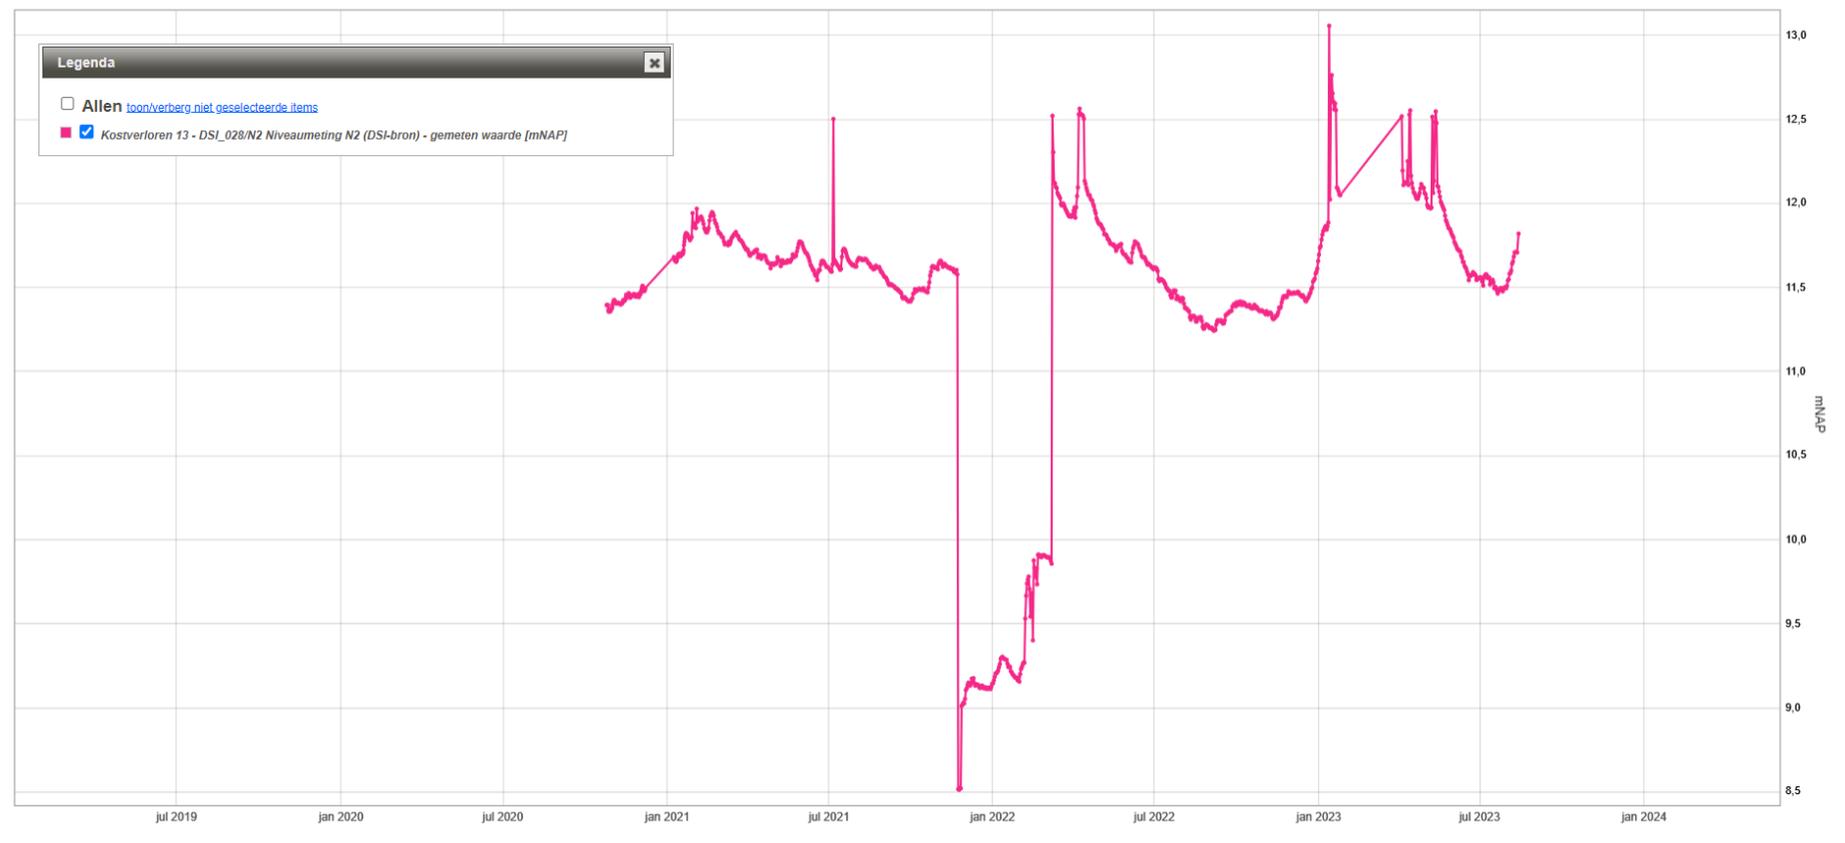
- Allen** [toon/verberg niet geselecteerde items](#)
- Kostverloren 13 - DSL_028/N2 Niveaumeting N2 (DSL-bron) - gemeten waarde [mNAP]**

dinsdag 1 januari 1919 00:00 tot zaterdag 1 juni 2024 00:00
