Field research on burrows and discontinuities in embankments

Fact Finding field research in the Hedwige-Prosperpolder

STOWA Report no:

2021-52

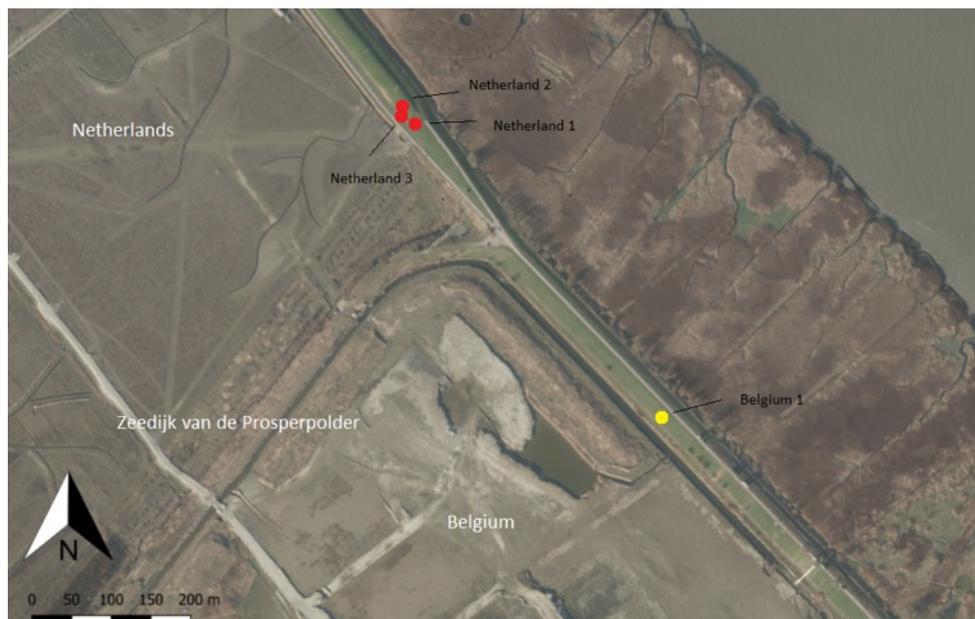
The locations of interest that were found during the initial field visit at the Dutch and Belgian sites are presented in figure 3.

Figure 3 Test locations at the Belgium and Dutch site of the Hedwige-Prosperpolder

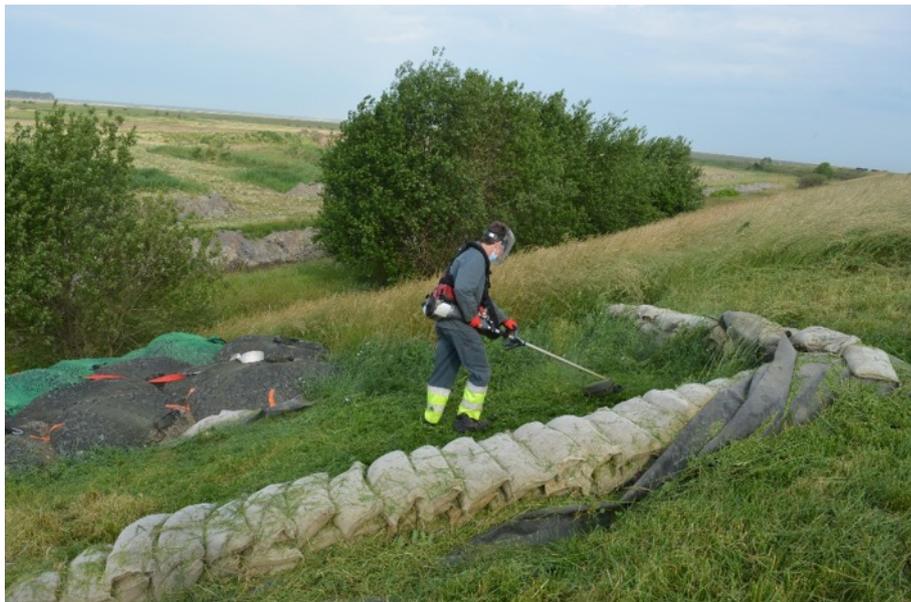
During the initial field visit little to no changes were observed in comparison with previous visits. Based on visual inspection, and the previous use of paint-markers, the rock bags appeared to be at the same place and orientation as they were left behind at the end of March 2021. The grass cover had grown very high at this location since mowing activities have not taken place here recently. Therefore, the grass was mown (Figure 8).

Figure 8 Preparation of test location, mowing grass

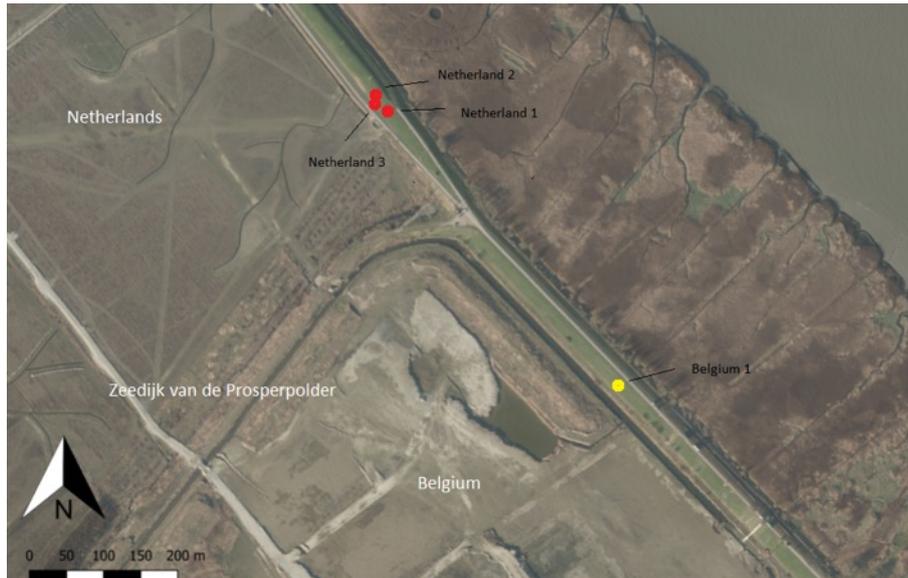
Figure 13 Focus areas at the Dutch (red) and Belgian (Yellow) side of the Hedwige-Prosperpolder

At the Dutch site location three focus-areas were identified (Figure 13). One that was relevant for comparison with the Belgian site location. And another, for a more detailed investigation to the observed cracks. Based on expert-judgement another location was identified as focus area because of potential mice-activities.
